The pages to follow contain your TOTAL HOME INSPECTION report, which is based on observations made while conducting an inspection of Any Address, Anywhere, Fairfield County.

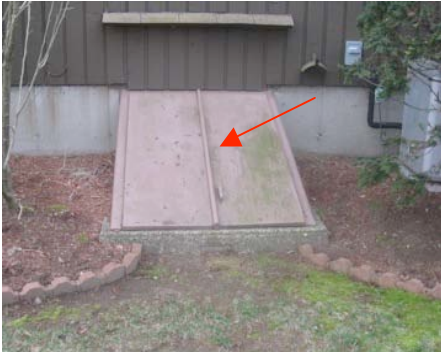
We also recommend that you seal the vulnerable areas of the bulkhead entrance (see photo left) and cover it in the winter, as required to help ensure a weather tight seal.

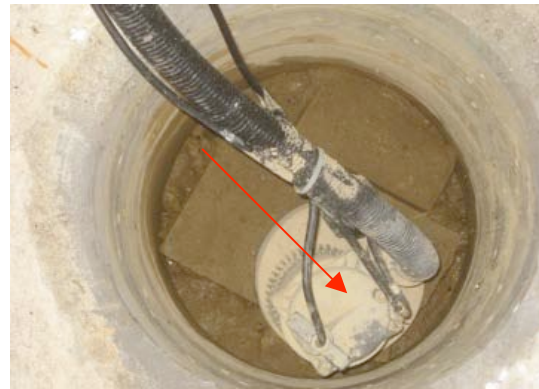
The sump pump (see photo right) appeared to be operating properly at the time of this inspection. Sump pumps should be kept in good working order and tested several times a year. We recommend that you install a battery operated back-up system for the sump pump to help ensure its operation during a power outage.

The sump hole should be covered to minimize the amount of moisture being released into the basement and to help reduce the radon level in the basement.

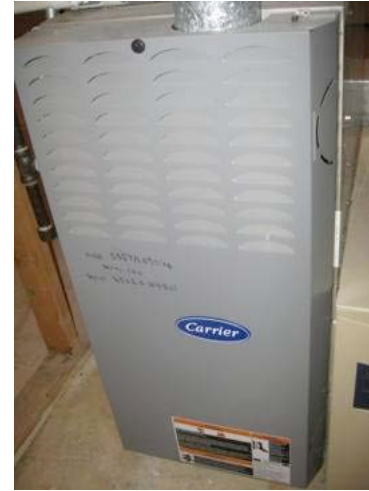
The heating plant is a gas-fired, steel, Carrier brand furnace (serial # 4502A44801 / model # 58STA090-14-see photo right). The furnace fired satisfactorily at the time of this inspection. It should be cleaned, including flue passages, and all components adjusted to operate at peak performance. The fan unit and blades should be vacuumed and lubricated, as required, and the belts adjusted or replaced. All safety devices should be checked. The heat exchanger should be inspected for cracks and /or leaks prior to your closing (the heat exchanger can only be totally inspected by dismantling the furnace). If it cannot be verified that this furnace and its components have been serviced and cleaned within the past year, arrangements should be made for that servicing.

The furnace appears to be approximately 7 years old. Furnaces that have been properly maintained have an average useful life expectancy of approximately 15-20 years.

The air filter in the furnace needs changing now and every six to eight weeks of operation or as necessary.

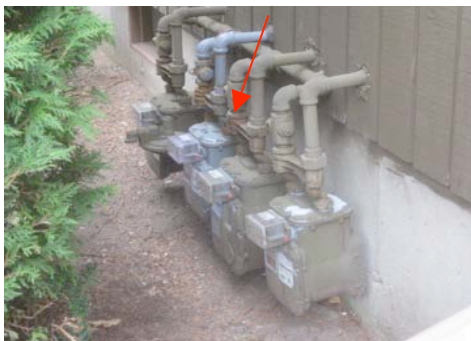
The main fuel (natural gas) meter and shut off valve are located at the front of the exterior of the building, between units 83-A and 83-B. (see photo left-arrow indicates shut-off valve)

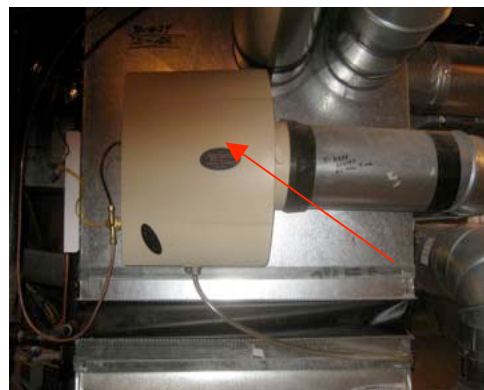
The humidifier (see photo right) should be serviced in accordance with the manufacturer's recommended procedures. Humidifiers are prone to leaking. If leaking occurs the humidifier should be serviced promptly to prevent damage to the heat exchanger and /or to the ductwork. We do not recommend the use of this type of humidifier. The humidifier bypass should be open during the heating season and closed during the cooling season.

The waste water of the humidifier drains into the waste piping. This is not recommended because when the drain traps dry out during the cooling season sewer gases can enter the air handler and possibly be distributed into the living space. We recommend re-routing the drain to the exterior of the building or into the sump hole and sealing the waste pipe to prevent the gases from entering the basement space.

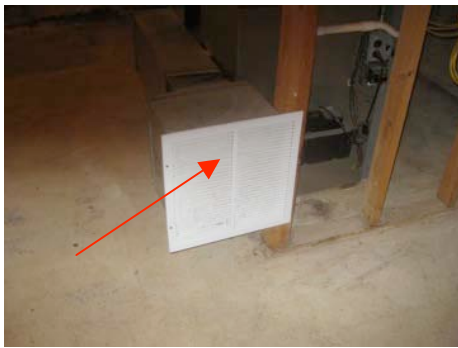
The heat distribution is multiple zones of forced hot air. All heat sources were adequately warm, except for the supply vents in the living room (rear left corner) and in the basement (rear ceiling vent/ duct). There could be several causes for this condition. A qualified HVAC service company should make the necessary repairs or adjustments for your comfort.

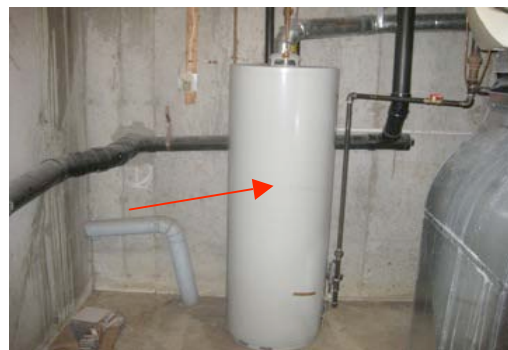
The water is heated by an independent, 50-gallon, gas-fired, State Select brand, water heater (serial # F03220118-see photo right) with a recovery rate of 80 gallons per hour. The hot water supply system was evaluated and found to provide adequate amounts of hot water to all fixtures tested, at the time of this inspection.

According to our inspector's thermometer, the undiluted hot water temperature was approximately 113.3 degrees Fahrenheit. It is recommended that the undiluted hot water temperature remain between 115 degrees Fahrenheit and 125 degrees Fahrenheit to prevent scalding and for your comfort. Make the appropriate adjustments for your comfort purposes.

The water heater appears to be 6 years old. The water heater unit was in generally acceptable condition. Water heaters that service municipal water supplies and that are properly maintained have an average useful life expectancy of 12-18 years. These units deteriorate from the inside out. We have no way of determining the interior condition of the water heater.

We recommend installing a pan and a drain under the water heater to prevent damage caused by a system failure or the discharge from the safety device.

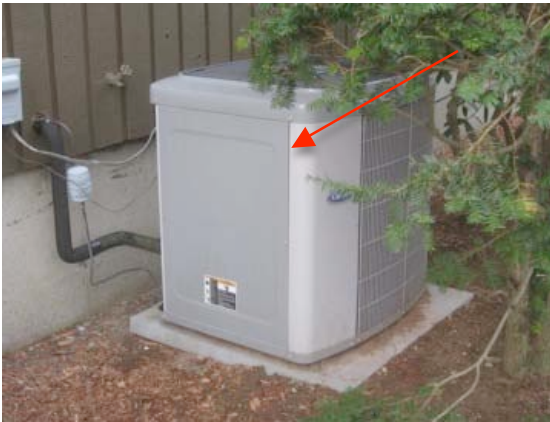
The Carrier brand, electric, air conditioning system compressor (serial # 0303E07578- see photo left) was not activated due to the low exterior temperatures. Most manufacturers recommend, in order to avoid damage, that these units not be activated when exterior temperatures fall below 65 degrees Fahrenheit. Obtain some type of guarantee from the seller that this unit will be in good working condition when needed. For maximum efficiency, service

The exterior compressor appears to be 6 years old. Air conditioning systems that are properly maintained have an average useful life expectancy of 10-15 years.

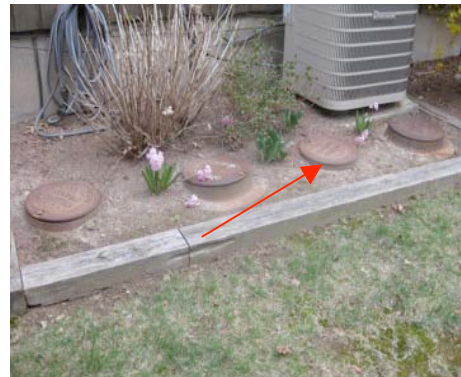
The buried meter and the remote, exterior meter reader are located on the left side of Unit #83-A. The remote, exterior meter reader, dangling at the left side of Unit #83-A, should be secured to help allow the device to function as designed (see photo of buried meter at right).

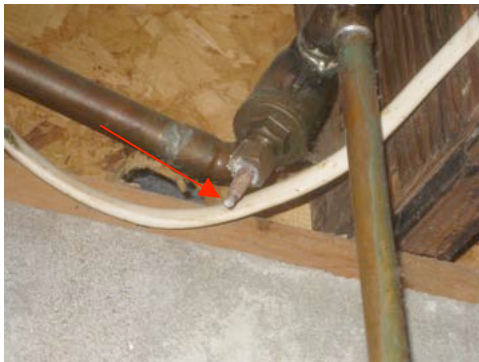
The visible water supply lines are copper, plastic and braided-metal and they were in generally acceptable condition. We recommend that all water supply pipes be insulated for better energy efficiency, to prevent condensation and to protect them from the elements.

The missing, valve handle for the main water shut off valve should be replaced for your safety and for your convenience.

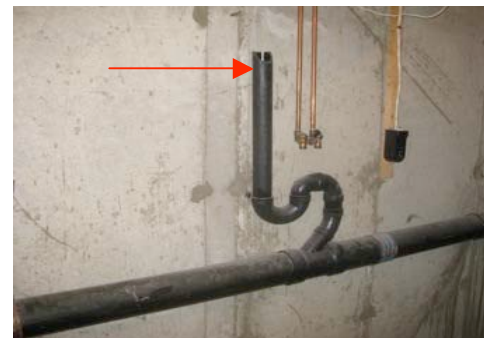
The unused, uncovered waste pipes should be capped as required to help prevent sewer gases from possibly entering the basement and the living space (see photo right for example).

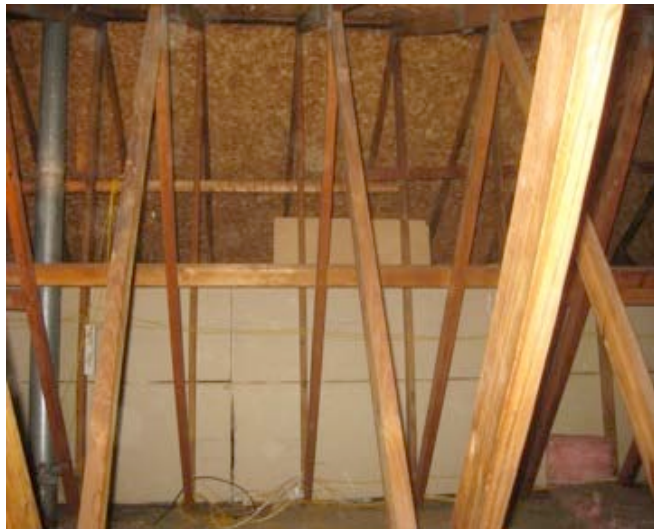
The attic framing and roof structure consists of 2" x 4" roof trusses installed 24" on center and 2" x 4" floor boards installed 24" on center. The roof has been sheathed with oriented strand boards ("OSB") - see photo above.

The structural floor framing in the attic space is undersized and not adequately supported from below for storage of any but your lightweight belongings.

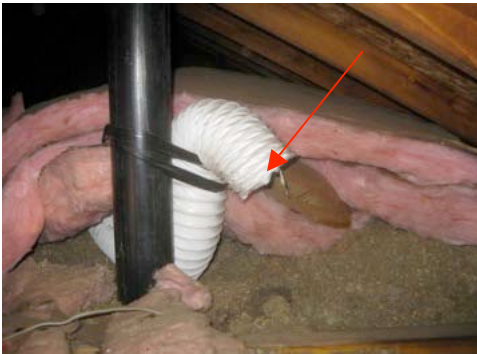
The bathroom exhaust fan that terminates in the attic space (see photo left) should be vented to the exterior of the building to help reduce moisture levels in the attic space.
