The pages to follow contain your TOTAL HOME INSPECTION report, which is based on observations made while conducting an inspection of Any Address, Anywhere, Fairfield County.

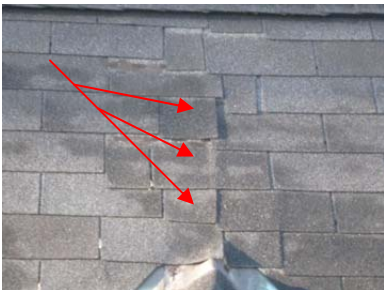
The roof surfaces were showing normal wear and they were generally in acceptable

condition. The loose shingles over the main house's front entrance area (see photo - above left) should be secured and the tarred shingles (see photo - above right for example) on the main house should be maintained as required to help ensure a weather tight roof surface.

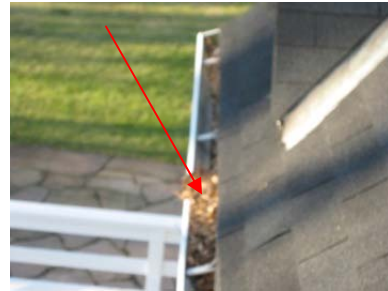
The sagging sections of gutter at the front left and front right of the house should be re-pitched as required. All gutters should be pitched toward their downspouts and the leaders should terminate as far from the building as practical. Gutters and rain leaders must remain free flowing at all times.

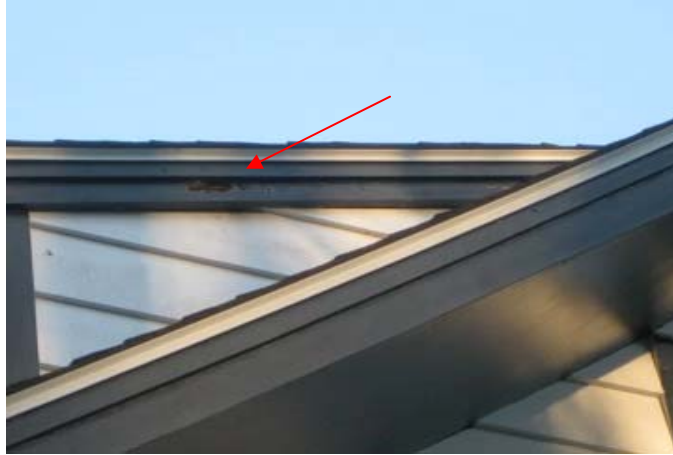
house damaged by carpenter bees and/or woodpeckers (see photo), as well as at the window and door casing perimeters, the unions between siding and trim components and the unions between exterior cladding and foundation will help to establish and maintain a weather tight envelope for the house, and will protect the siding and substrates from exposure to moisture and deterioration.

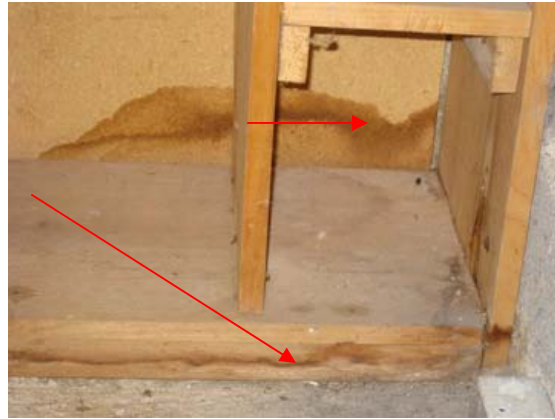
Watermarks were evident in the basement area (see photo for example). This indicates water has entered this area in the past. The basement was dry at the time of the inspection. Be sure that all exterior grades pitch away from the foundation and extend the guttering system as far away from the foundation as practical (see **LANDSCAPING** and **BUILDING EXTERIOR** sections of this report). It must be noted that any area below grade is susceptible to water seepage during certain weather conditions. If after performing the above recommendations, water seepage is still evident, consultation with a waterproofing specialist may be necessary.

As representative measures toward controlling general dampness in the lowest level, we recommend that the cold water lines be insulated and that you consider installing a fan to enhance airflow and a dehumidifier to actively extract moisture from the area.

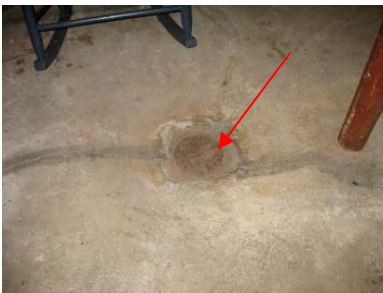
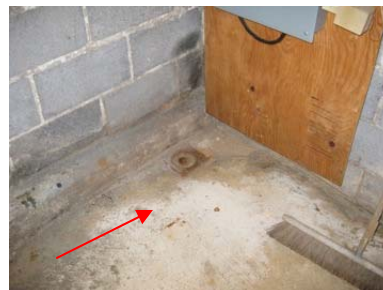
The floor drains should be kept clean and free flowing at all times to help allow them to function as designed (see photos).

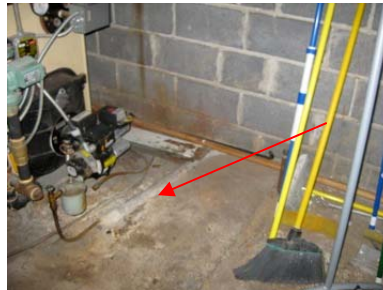
A small portion of the oil supply pipes are covered with concrete, preventing evaluation of the oil supply pipes. The copper pipes are likely to be adversely affected by their contact with the concrete. It should be noted that oil could leak from these pipes below the concrete. We recommend that you have your oil supplier re-route the oil lines as required to remedy this condition and that the pipes be encased in protective sleeves to help prevent damage to the pipes.

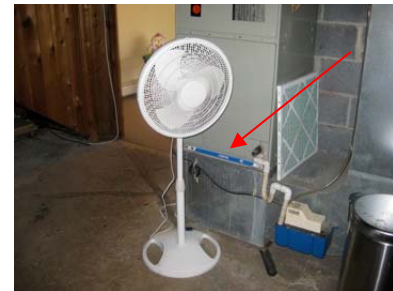
Some of the air handlers' "return air" is drawn from the basement area and from the attic because the filter compartment covers are missing (see photo for basement air handler). This is not a recommended practice because air contaminants in the basement and attic will be drawn into the living areas. Replace the filter compartment covers or install duct tape over the filter compartment access areas as required to help remedy this condition.

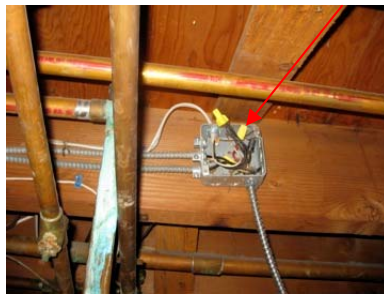
There are exposed right unfinished example). All including electrical should be properly boxes should be removable cover

electrical wires in the front basement area (see photo for electrical wire connections, wall outlets and wall switches housed in boxes and those covered with a secure for your safety.

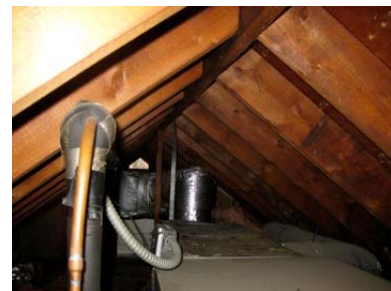
Access could not be gained to the attic area above the master bedroom due to the small portal, the lack of flooring and the "low ceiling" in the area (see photo). The area could not be inspected therefore we cannot include an evaluation of the contents, structural components, roof sheathing, insulation, ventilation, flooring or

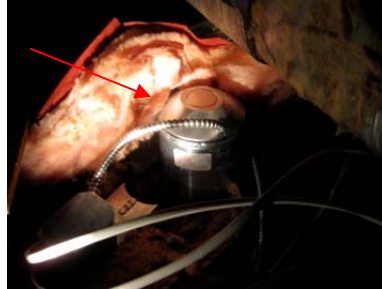
Insulation should not be close proximity to heat-e.g., deficient electrical wiring or open recessed or surface mounted exhaust flues of heat-Heat-emitting objects like in contact with insulation, potential fire hazard. Remove the insulation as necessary (see photo for example in this attic).

installed over or in emitting objects, systems, exposed junction boxes, light fixtures or producing devices. these, covered by or may represent a

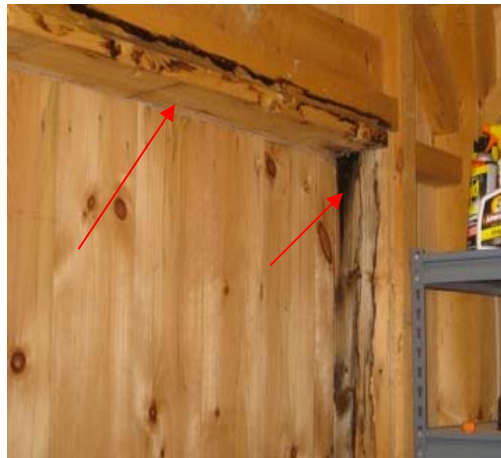
Evidence of past (active?) leaking was observed around the sliding door (see photo). The source of the leaking should be determined and repaired to help ensure a weather tight seal and to help prevent damage to the garage structure

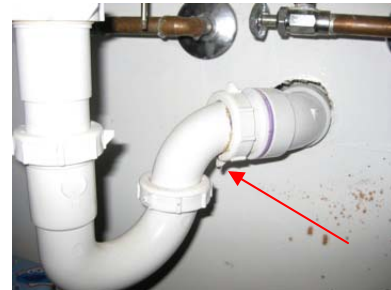
Front Left Side Bathroom: The cause for the leaking beneath the sink should be determined and repaired to help prevent continued leaking and consequential damage (see photo of drip).
