The pages to follow contain your TOTAL HOME INSPECTION report, which is based on observations made while conducting an inspection of Any Address, Anywhere, Fairfield County.

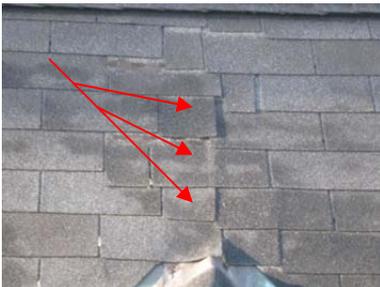
condition. The loose shingles over the main house's front entrance area (see photo - above left) should be secured and the tarred shingles (see photo - above right for example) on the main house should be maintained as required to help ensure a weather tight roof surface.

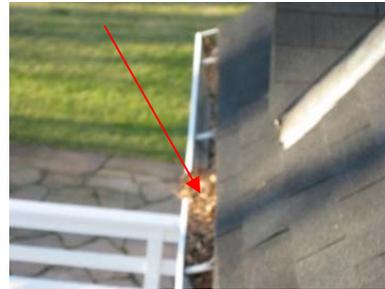
The sagging sections of gutter at the front left and front right of the house should be re-pitched as required. All gutters should be pitched toward their downspouts and the leaders should terminate as far from the building as practical. Gutters and rain leaders must remain free flowing at all times.

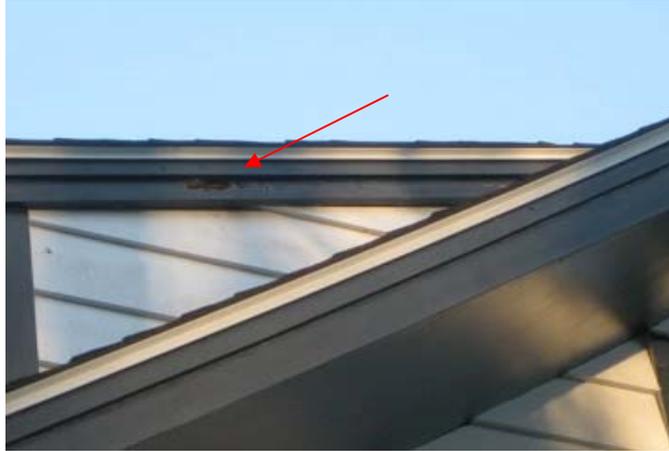
The house is clad with wood clapboard and vertical, knotty wood siding and with wood trim. The garage is clad with vertical, knotty wood siding as well as with wood trim. They were in generally acceptable condition. Secure the loose trim on the right side screened in porch. Sealing all penetrations, seams, and voids in the siding, including the areas of the main

house damaged by carpenter bees and/or woodpeckers (see photo), as well as at the window and door casing perimeters, the unions between siding and trim components and the unions between exterior cladding and foundation will help to establish and maintain a weather tight envelope for the house, and will protect the siding and substrates from exposure to moisture and deterioration.

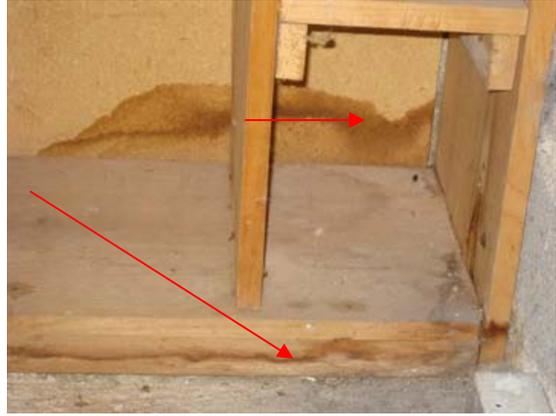
Watermarks were evident in the basement area (see photo for example). This indicates water has entered this area in the past. The basement was dry at the time of the inspection. Be sure that all exterior grades pitch away from the foundation and extend the guttering system as far away from the foundation as practical (see **LANDSCAPING** and **BUILDING EXTERIOR** sections of this report). It must be noted that any area below grade is susceptible to water seepage during certain weather conditions. If after performing the above recommendations, water seepage is still evident, consultation with a waterproofing specialist may be necessary.

As representative measures toward controlling general dampness in the lowest level, we recommend that the cold water lines be insulated and that you consider installing a fan to enhance airflow and a dehumidifier to actively extract moisture from the area.

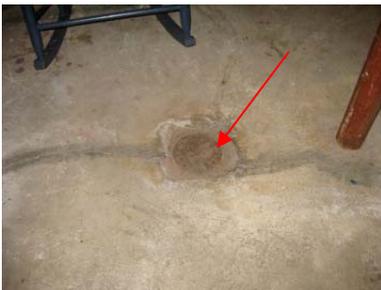
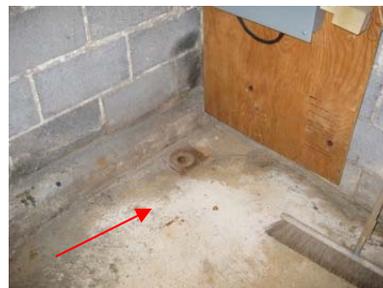
The floor drains should be kept clean and free flowing at all times to help allow them to function as designed (see photos).

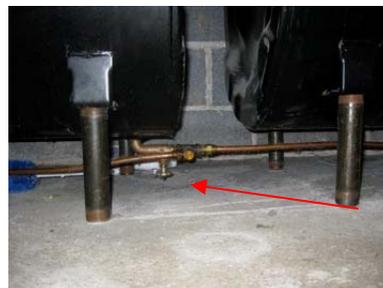
The main fuel (#2 heating oil) shut off valves are located in the basement at the bases of the two, 8-year old, 275-gallon oil storage tanks (see photo-right).

The visible areas of the oil storage tanks were in generally acceptable condition. Oil storage tanks have an average useful life expectancy of 30-40 years but the life expectancy can be affected significantly by the environment around the tank.

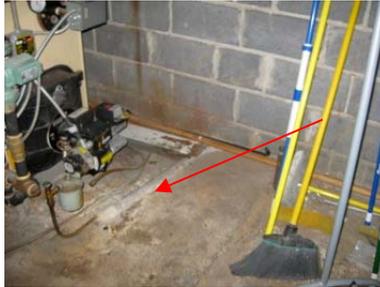
A small portion of the oil supply pipes are covered with concrete, preventing evaluation of the oil supply pipes. The copper pipes are likely to be adversely affected by their contact with the concrete. It should be noted that oil could leak from these pipes below the concrete. We recommend that you have your oil supplier re-route the oil lines as required to remedy this condition and that the pipes be encased in protective sleeves to help prevent damage to the pipes.

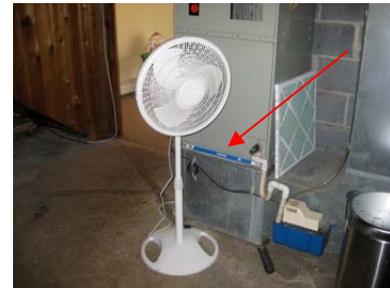
Some of the air handlers' "return air" is drawn from the basement area and from the attic because the filter compartment covers are missing (see photo for basement air handler). This is not a recommended practice because air contaminants in the basement and attic will be drawn into the living areas. Replace the filter compartment covers or install duct tape over the filter compartment access areas as required to help remedy this condition.

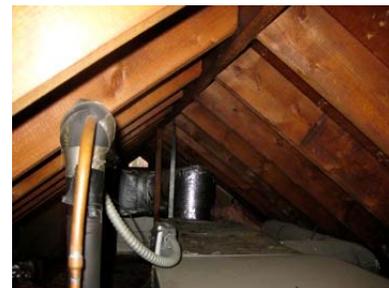
Access could not be gained to the attic area above the master bedroom due to the small portal, the lack of flooring and the "low ceiling" in the area (see photo). The area could not be inspected therefore we cannot include an evaluation of the contents, structural components, roof sheathing, insulation, ventilation, flooring or

lighting in this space, within this report. The accessibility, structure, lighting and flooring were in generally acceptable condition.

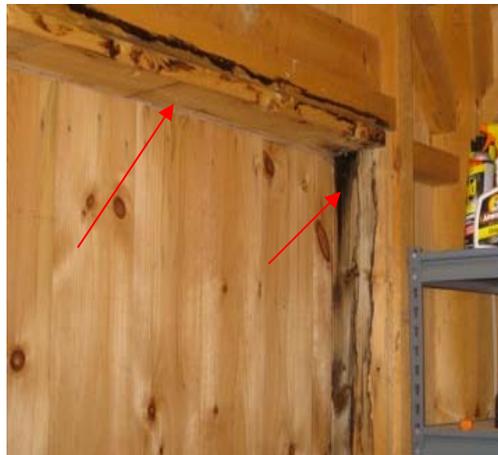
Evidence of past (active?) leaking was observed around the sliding door (see photo). The source of the leaking should be determined and repaired to help ensure a weather tight seal and to help prevent damage to the garage structure

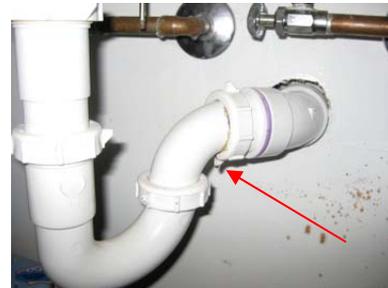
**Front Left Side Bathroom:** The cause for the leaking beneath the sink should be determined and repaired to help prevent continued leaking and consequential damage (see photo of drip).
