The pages to follow contain your TOTAL HOME INSPECTION report, which is based on observations made while conducting an inspection of ANY HOUSE, FAIRFIELD COUNTY.

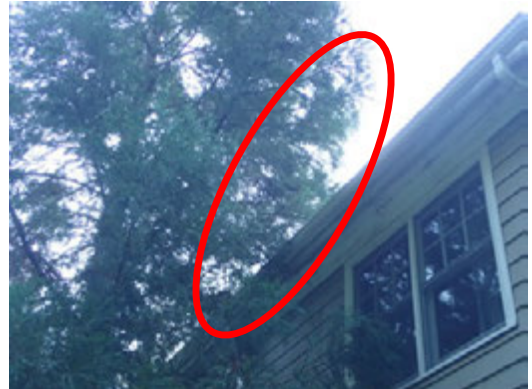
There are branches touching and overhanging the roof and gutter system (see photos left and right for example areas). By trimming or removing them, you will likely

reduce roofing, gutter and siding maintenance and repair and you will also remove a potential bridge for animals.

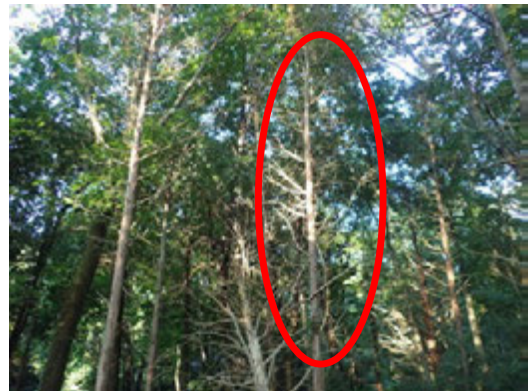
There are trees, which appear to be dead, at the rear left of the property (see photos left and right). We recommend that the trees be removed for your safety and to help prevent harm or

damage should the trees fall.

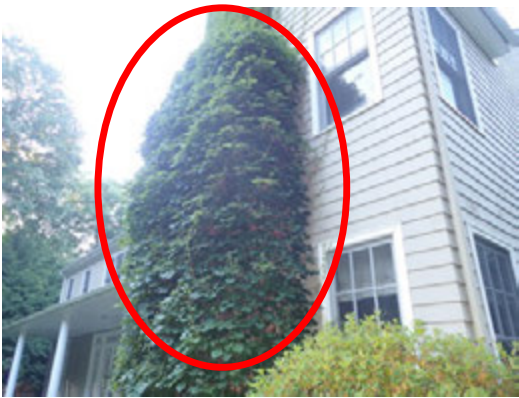
The shrubbery needs pruning (see photo right for example area). Trimming the plantings away from the foundation and building to afford a minimum of twelve inches of clearance between the shrubs and exterior cladding will help prevent moisture from being trapped against the structure, potentially promoting rot on and beneath vulnerable exterior components.

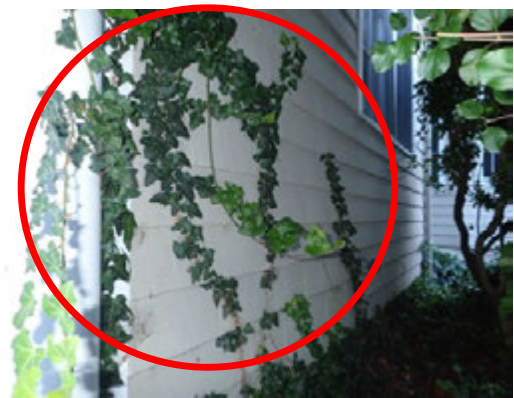
The tendrils of the vines clinging to the rear left center chimney and to the siding as well as the foundation (see photos left and right for examples) can damage the chimney

structure and to the siding as well as the foundation and to the vulnerable exterior cladding and the materials beneath the siding and trim components in these areas. The foliage can also provide an inviting environment for moisture and insects. Consider removing the offending vines.

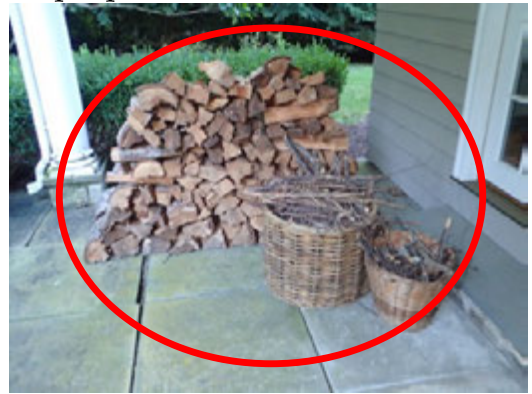
The firewood on the rear entrance landing/patio (see photo right) should be relocated. Firewood should never be stored inside nor in such close proximity to a building structure, as it is an environment conducive to attracting insects. Moving the firewood to a location as far away from the structure as is practical is recommended.

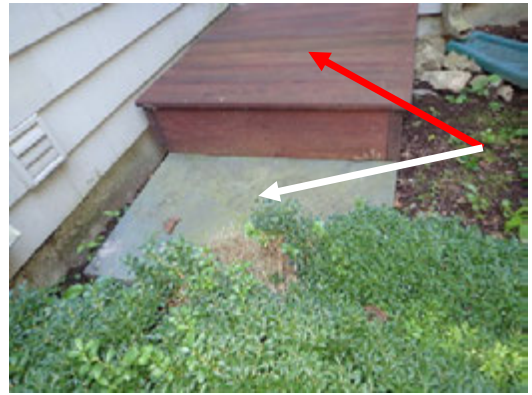
Keeping the wooden, rear left center entrance landing surfaces and its structural components treated with a quality wood preservative, paint or stain will help prolong the landing's life (see photo right – red arrow). Secure the loosely installed slate stone "step" at the rear left center entrance (see photo right – white arrow) for your safety and for your convenience.

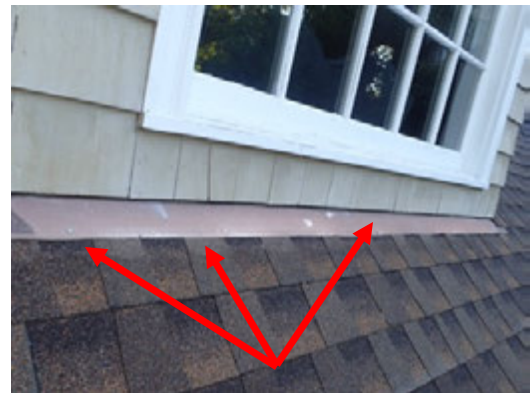
There were exposed nail heads observed on the lower front center roof flashing (see photo right) that should be sealed as required to help ensure that no precipitation can infiltrate the roof cladding and substrate.

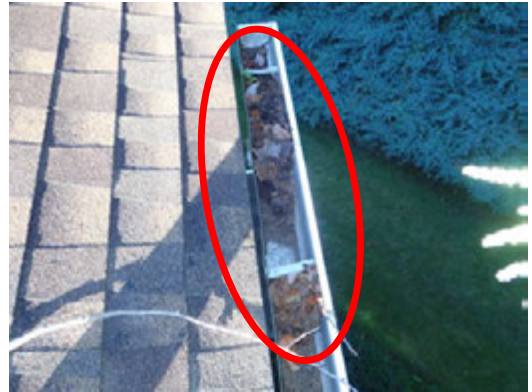
Portions of the guttering system require cleaning now and at least every spring and multiple times during the fall in the future (see photo right for example of offending area). If these gutters are not cleaned, you will experience ant infestation and a general rotting condition.

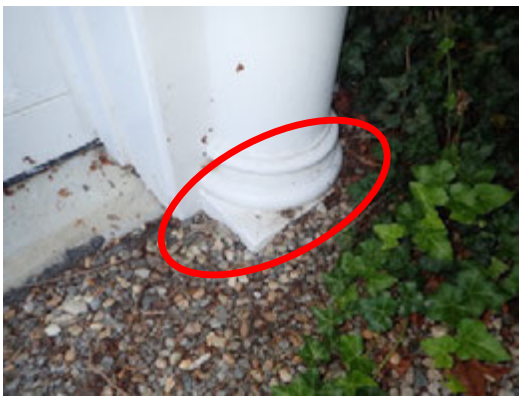
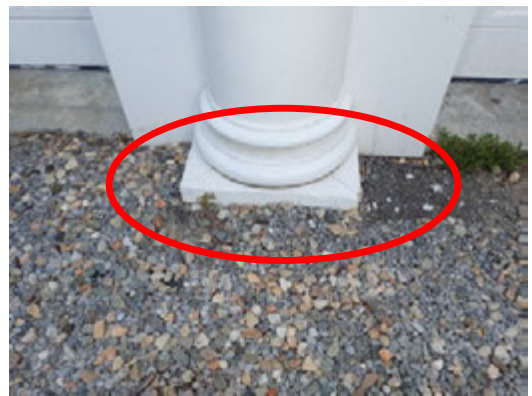
There are areas of garage door trim that were embedded in the driveway surface (see photos left and right for examples). This will eventually lead to a rotting condition and may invite

insects. Keep these areas free from debris and inspect them for rot or insect infestation annually.

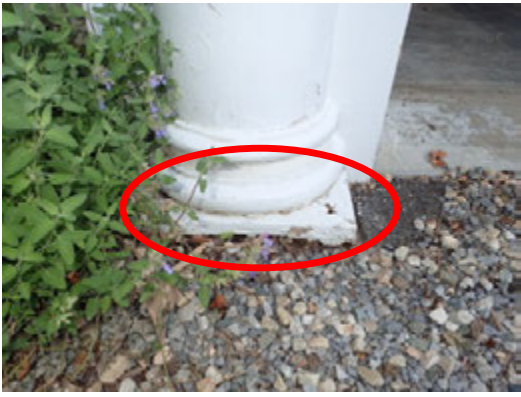
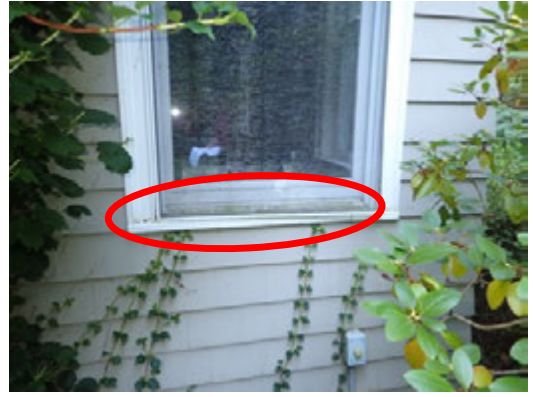
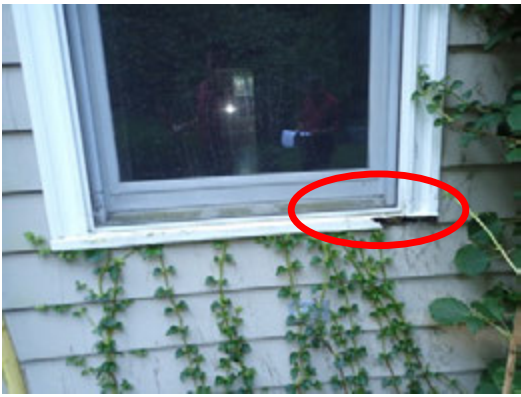
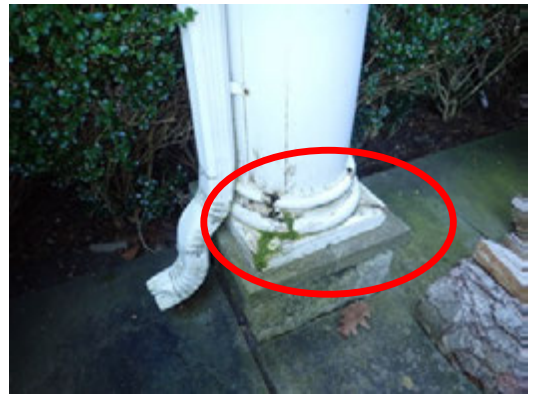
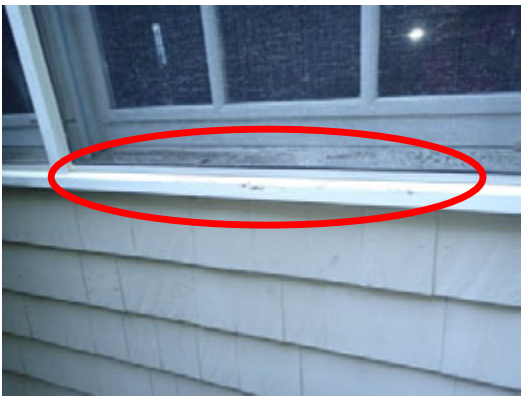
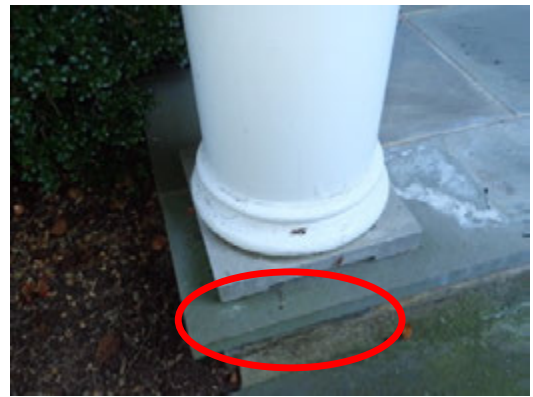
There were places around the house where rot or the onset of wood rot was observed, for example front left corner garage door trim / pillar base, at the family room rear left side window trim, at the rear right family room window trim, at the rear right landing / patio pillar base, at the rear left center family room window trim and at the front entrance pillar base (see six photos below for examples). This and all rotted or potentially rotted wood should be removed, and the sub-surfaces should be repaired as necessary. When the sub-surfaces are repaired, new wood should be installed, caulked and painted. Potentially rotting wood that is not repaired remains an invitation to insect infestation. When the sub-surfaces are exposed, if any insect activity is found, it should be treated as necessary at that time.

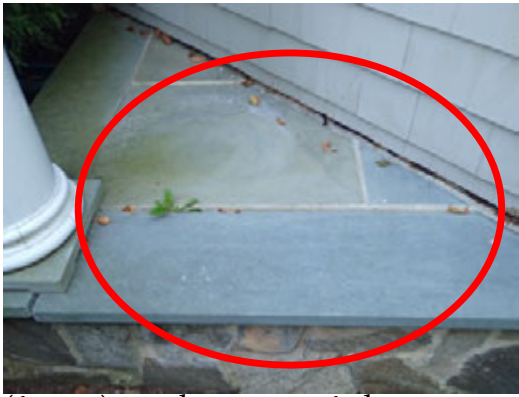
We observed gaps, voids and open mortar joints as well as a loose slate stone in the front right corner slate stone surface (see photo left) that should be repaired to help prevent water infiltration and damage to the patio and potentially to the patio substrate, at-grade and sub-grade foundation and interior spaces.

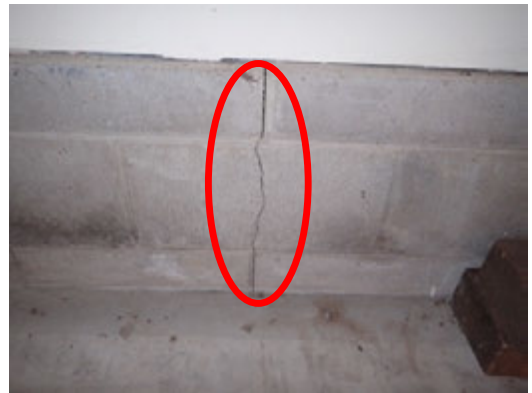
The foundation walls are poured concrete and concrete blocks. Settlement cracks were noted in the foundation at the time of the inspection (see photos left and right for examples).

Settlement cracks are not uncommon and are usually the result of improper soil grading around foundations. This condition is presently not a structural problem. It must be noted that settlement cracks could develop into structural cracks. Periodic inspection of these cracks and proper care should prevent future problems. These cracks should be filled from the exterior with a suitable material to help prevent seepage and they should be monitored for any further movement.

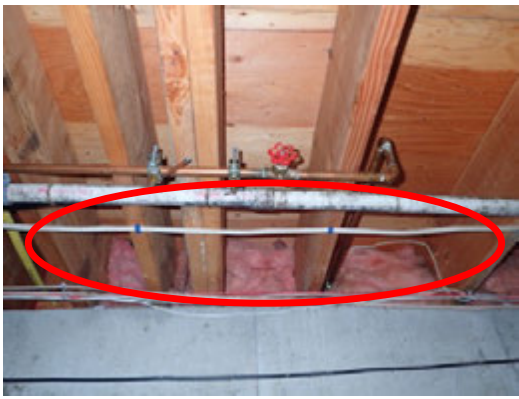
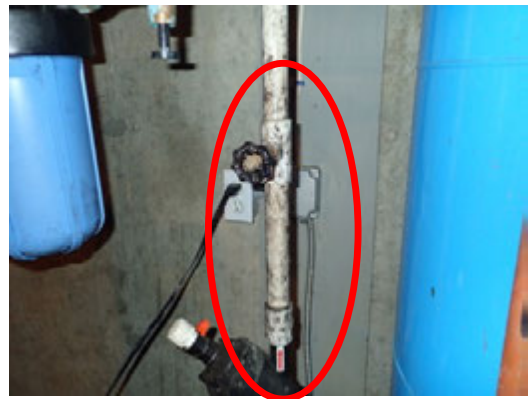
Black, microbial growth-type staining was observed in the basement on the PVC water supply pipes servicing the sprinkler system (see photos right and left for examples). This

condition is usually the manifestation of a space that requires additional ventilation and/or dehumidification. Add ventilation and/or dehumidification as necessary to help prevent microbial growth.

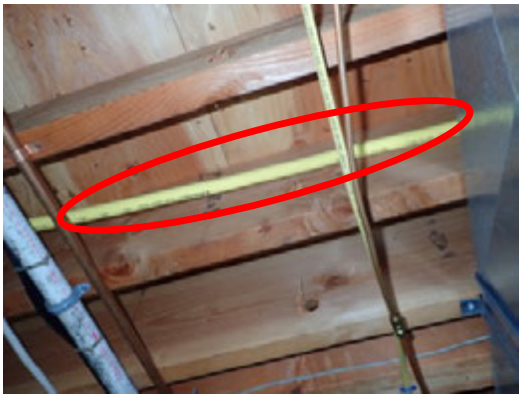
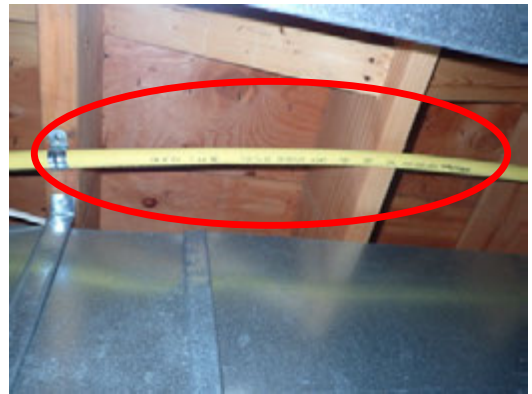
OmegaFlex brand, "Tracpipe" corrugated stainless steel tubing (CSST) was observed in the basement, apparently servicing the propane-fired kitchen cook top burners (see

photos above left and right for examples). This type of flexible tubing has thin walls and would be vulnerable to splitting in the event of the house incurring a lightning strike, for example. This type of propane delivering tubing requires a type of "bonding", pursuant to the manufacturer's requirement. For more information regarding the safety of this product, recommendations for homeowners with this corrugated stainless steel tubing in their homes, we recommend that you visit the internet's <http://www.pddocs.com/csst/default.aspx> We also recommend that you visit the manufacturer's web site for their perspective regarding this issue: http://www.omegaflex.com/trac/newsuploads/CounterStrike_Brochure_2008.pdf

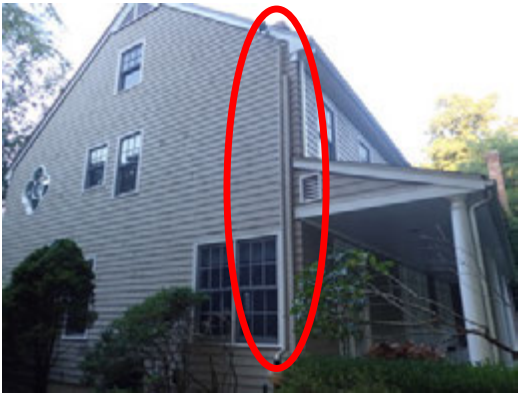
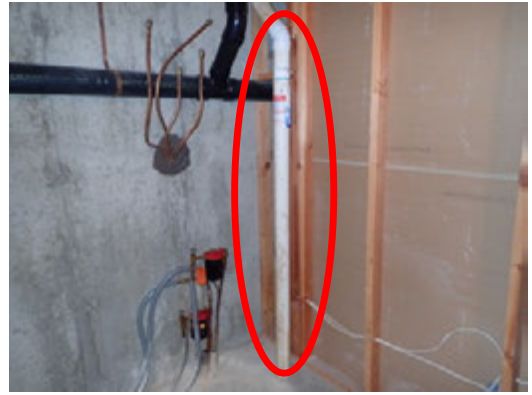
This house has been fitted with a radon mitigation system (see photo left of exterior components and see photo right of the manometer and piping inside the house). The system did not appear to be

functioning as designed at the time of this inspection. We recommend you (or the seller?) contact the installing contractor to make the system functional. The installing contractor should also provide you with an orientation for the equipment and inform you of any maintenance that is required either by you or by them. Further, we recommend that obtain any warranties or guarantees on this system from the installing contractor within 30 days of your closing.

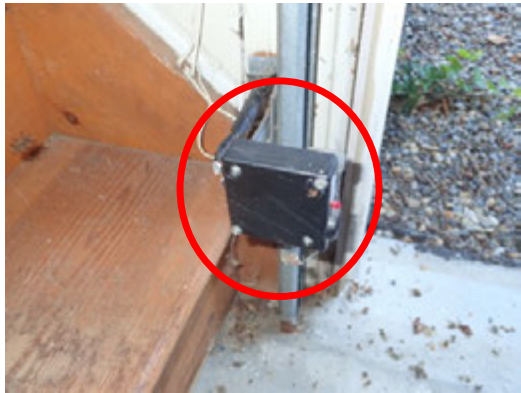
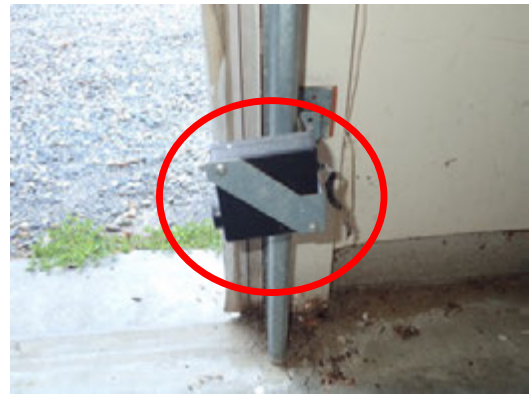
We recommend that you lower the "photo-sensitive eyes" servicing the right-most garage door (see photos left and right) to 6" above the garage floor to help allow them to function as designed and to

help prevent entrapment.

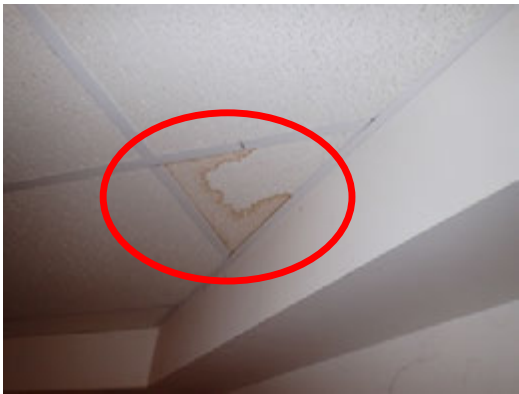
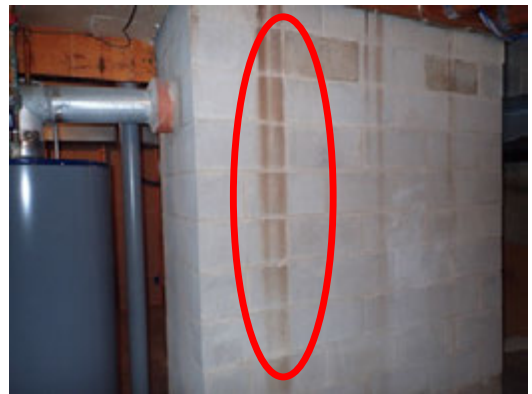
Dry stains or watermarks were observed on the ceiling in the finished basement exercise room (see photo left for one example area) and on the chimney structure in the rear right unfinished

basement area (see photo right). Inquire with the owner as to the cause for the staining, when it occurred and what measures were taken to help ensure that the staining will not recur.

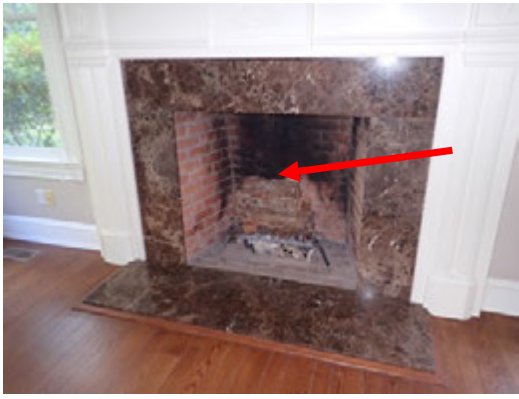
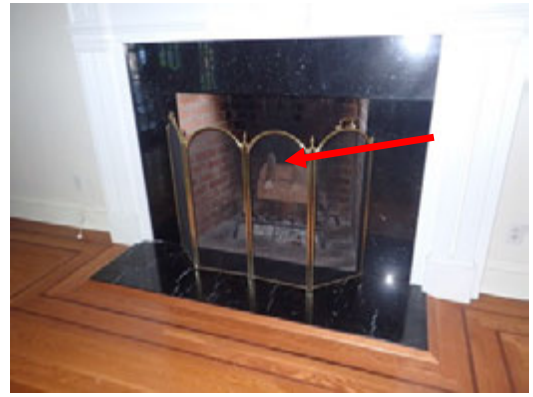
The configurations of the flues in the chimney structures servicing the masonry fireplaces' in the living room and in the family room (see photos left and right)

prevented our inspector from evaluating their entire lengths. We recommend that you confirm the flues' conditions, clearances and safety prior to using the fireplaces.
