The pages to follow contain your TOTAL HOME INSPECTION report, which is based on observations made while conducting an inspection of Any Address, Anywhere, Fairfield County.

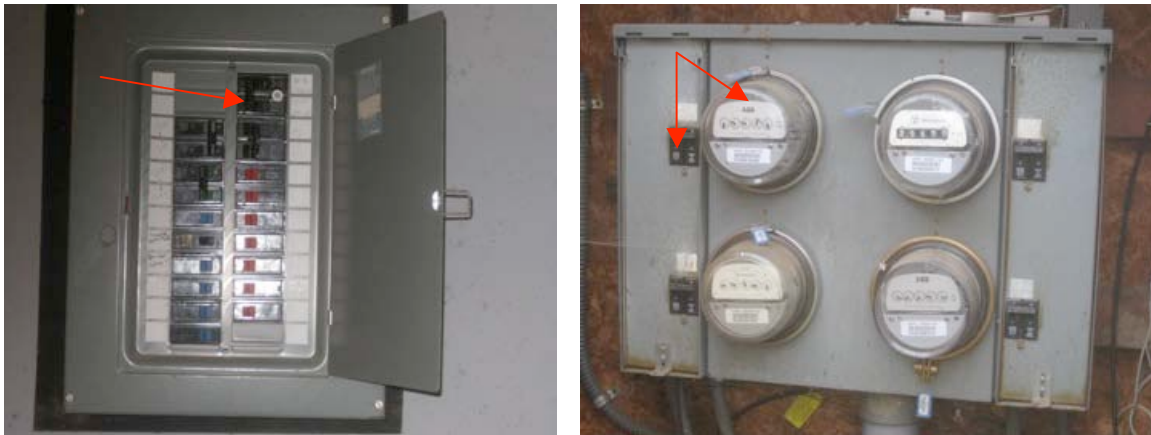
The 100-ampere, 120/240-volt electrical system enters the building via underground cables. The electric meter and main service disconnect switch are located on the exterior of the building (see photo above right) in a protective wooden structure. The interior main service disconnect switch and the distribution panel are located in the basement (see photo above left). The panel has been fed with aluminum feeders. Where visible the distribution conductors (wires) are copper, armored cable (AC/BX) and copper, non-metallic sheathed cable (NM/Romex) type conductors

(wires). They were in generally acceptable condition. All circuit breakers in the electrical panel should be properly labeled for your safety and for your convenience. The electrical breaker switches in the panel should be tested on an annual basis. The system appears to have been grounded to a driven rod.
