The pages to follow contain your TOTAL HOME INSPECTION report, which is based on observations made while conducting an inspection of Any Address, Anywhere, Fairfield County.

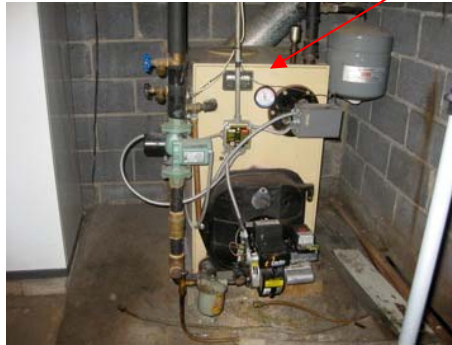
The heating plant for the and for the master (excluding the bedroom air system. This system aforementioned, Weil one air handler unit (in bedroom closet). The water, which then flows the air handler. A fan in blows over the coil and heated air ("forced warm air").

front left bedroom bedroom suite area) is a hydro-consists of the McLain boiler and the front left boiler heats the through a coil in the air handler distributes the

The boiler fired satisfactorily at the time of this inspection but it did not function at its peak performance levels (see below). The boiler should be cleaned including its smoke pipe and chimney flue passages, and all should be technically inspected and repaired if necessary. All components should be checked and adjusted to operate at peak performance, including all safety devices and automatic valves. This service work should be performed now and on an annual basis going forward.

There is back-pressure from the combustion chamber of the boiler. There could be several causes for this condition. A service company should evaluate and correct this condition.

The pressure reading on this boiler is lower (8 psi) than normal (12-20 psi). The cause could be a malfunctioning gauge or one of the boiler components. Have a reputable service company check and correct the cause of this condition.

There were corroded fittings and valves observed at and near the boiler. We recommend that these valves and fittings be monitored for further deterioration and that they be replaced when required to prevent malfunctions and potential damage.

The technician from Standard Oil recommends that a "spiral scoop" (turbulator") be installed on the boiler's heat pipes in such a way as to help allow the boiler to function at peak performance levels.

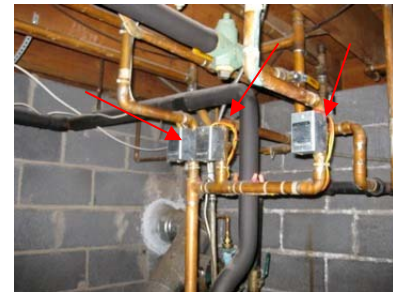
The baseboard heating zones are controlled by means of electric zone valves. This is a common, economical method of providing separate zones of heat in the house.

You might consider upgrading the non-programmable thermostats (heating and cooling) to the programmable type for better energy efficiency and for your convenience.

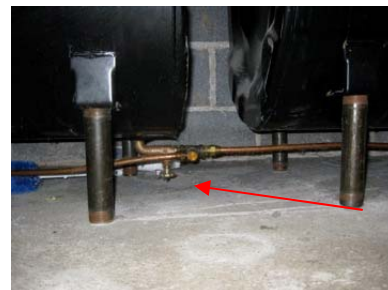
The main fuel (#2 heating oil) shut off valves are located in the basement at the bases of the two, 8-year old, 275-gallon oil storage tanks (see photo-right).

The visible areas of the oil storage tanks were in generally acceptable condition. Oil storage tanks have an average useful life expectancy of 30-40 years but the life expectancy can be affected significantly by the environment around the tank.

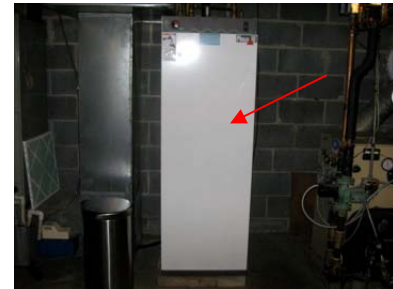
The water is heated by a Phase III brand, indirect, hot water maker (serial # I9822/model # TR60). This water heater works in conjunction with the boiler. The boiler heats water, which then passes through a jacket in the water heater and gives off its heat to the domestic water. The hot water system was evaluated and found to be in acceptable condition. This system is considered adequate to meet today's family needs. The system should be checked and maintained when the boiler is serviced.

According to our inspector's thermometer, the undiluted hot water temperature was approximately 147.2 degrees Fahrenheit. It is recommended that the undiluted hot water temperature remain between 115 degrees Fahrenheit and 125 degrees Fahrenheit to prevent scalding and for your comfort. Make the appropriate adjustments for safety purposes. The indirect water heater was in generally acceptable condition.

The indirect water heater appears to be 8 years old. Indirect water heaters that service well water supplies and that are properly maintained have an average useful life expectancy of 5 - 25 years, depending upon the properties of the well water they service. These units deteriorate from the inside out. We have no way of determining the interior condition of the indirect water heater unit.

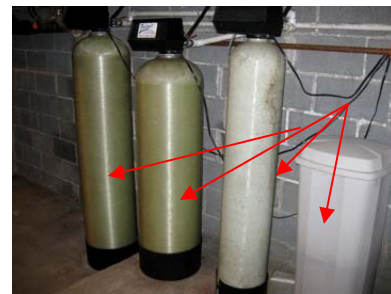
This house has water treatment equipment. The water treatment equipment was by-passed for one

of the water analysis samples and included in a second sample. The results of this testing will also be forwarded to you directly by JMS Environmental Services (toll free: 1-866-567-5097) under separate cover, in approximately 7 days. TOTAL HOME INSPECTION will not receive copies of the test results. Evaluating water treatment equipment is beyond the scope of a standard home inspection. There is no evaluation of the well water treatment equipment contained in this report. The installing contractor or homeowner should instruct you on its operation and maintenance.

The backwash for the water treatment equipment empties into the septic system. This is not recommended. Eventually the deposits in the backwash water may damage the system, clog the septic fields or filter down to the aquifers. The backwash, depending on its type, should be spilled into a separate dry well, or containerized and removed from the site. Inquire with the local health department as to their requirements.

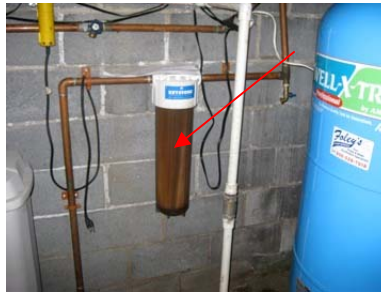
A "macro-type" filter has been installed on the water supply system to extract from the water supply. We you ask the seller or a qualified, filtration system, installer to how to maintain and remove safety and to help prevent consequential damage.

installed on the larger particles recommend that well water instruct you on the filter for your leaking and

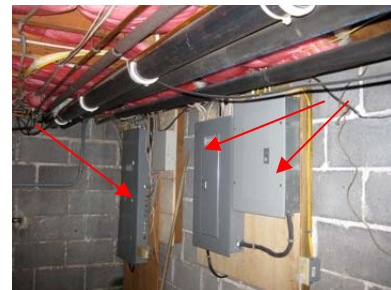
The 200-ampere, 120/240-volt electrical system enters the building via underground cables. The electric meter and main service disconnect switch are located on the exterior of the building. The main distribution panel is located in the rear left unfinished basement area. There are also sub panels

located in the same basement area (see photo). The main distribution panel has been fed with aluminum feeders. The sub panels have been fed with copper. Where visible the distribution conductors (wires) are copper, armored cable (AC/BX) and copper, non-metallic sheathed cable (NM/Romex) type conductors (wires). They were in generally acceptable condition. All circuit breakers in the electrical panel should be properly labeled for your safety and for your convenience. The electrical breaker switches in the panel should be tested on an annual basis. The four existing "Ground Fault Circuit Interrupter" (GFCI) safety breakers in the main panel should be tested monthly. The system appears to have been grounded to driven rods.

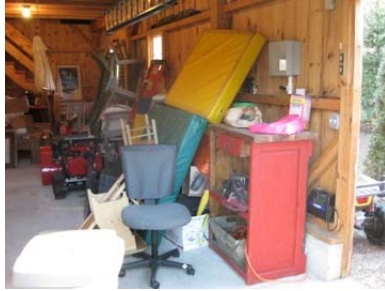
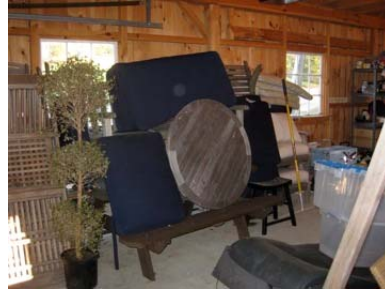
Due to the locations of the considerable amount of stored materials/belongings in the garage, we were unable to definitively verify its condition (see photos below).
