The pages to follow contain your TOTAL HOME INSPECTION report, which is based on observations made while conducting an inspection of Any Address, Anywhere, Fairfield County.

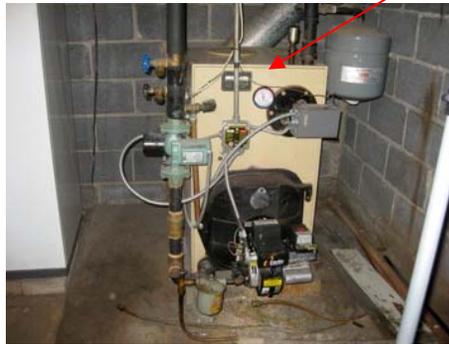
The heating plant for the and for the master (excluding the bedroom air system. This system aforementioned, Weil one air handler unit (in bedroom closet). The water, which then flows the air handler. A fan in blows over the coil and heated air ("forced warm air").

front left bedroom bedroom suite area) is a hydro-consists of the McLain boiler and the front left boiler heats the through a coil in the air handler distributes the

The boiler fired satisfactorily at the time of this inspection but it did not function at its peak performance levels (see below). The boiler should be cleaned including its smoke pipe and chimney flue passages, and all should be technically inspected and repaired if necessary. All components should be checked and adjusted to operate at peak performance, including all safety devices and automatic valves. This service work should be performed now and on an annual basis going forward.

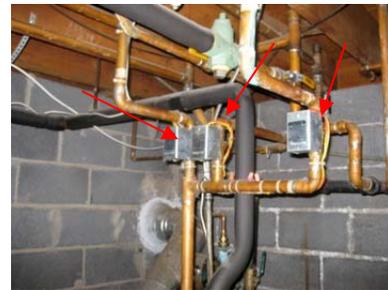
The baseboard heating zones are controlled by means of electric zone valves. This is a common, economical method of providing separate zones of heat in the house.

You might consider upgrading the non-programmable thermostats (heating and cooling) to the programmable type for better energy efficiency and for your convenience.

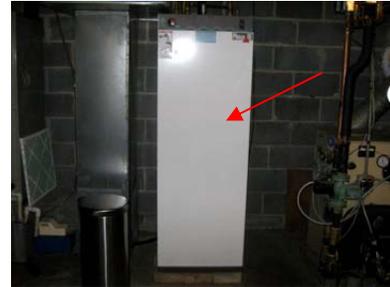
The water is heated by a Phase III brand, indirect, hot water maker (serial # I9822/model # TR60). This water heater works in conjunction with the boiler. The boiler heats water, which then passes through a jacket in the water heater and gives off its heat to the domestic water. The hot water system was evaluated and found to be in acceptable condition. This system is considered adequate to meet today's family needs. The system should be checked and maintained when the boiler is serviced.

According to our inspector's thermometer, the undiluted hot water temperature was approximately 147.2 degrees Fahrenheit. It is recommended that the undiluted hot water temperature remain between 115 degrees Fahrenheit and 125 degrees Fahrenheit to prevent scalding and for your comfort. Make the appropriate adjustments for safety purposes. The indirect water heater was in generally acceptable condition.

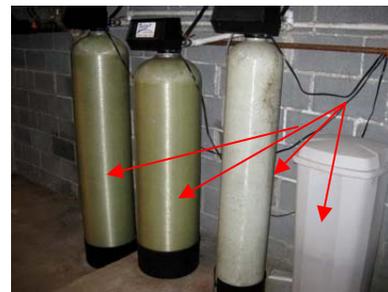
This house has water treatment equipment. The water treatment equipment was by-passed for one

of the water analysis samples and included in a second sample. The results of this testing will also be forwarded to you directly by JMS Environmental Services (toll free: 1-866-567-5097) under separate cover, in approximately 7 days. TOTAL HOME INSPECTION will not receive copies of the test results. Evaluating water treatment equipment is beyond the scope of a standard home inspection. There is no evaluation of the well water treatment equipment contained in this report. The installing contractor or homeowner should instruct you on its operation and maintenance.

The backwash for the water treatment equipment empties into the septic system. This is not recommended. Eventually the deposits in the backwash water may damage the system, clog the septic fields or filter down to the aquifers. The backwash, depending on its type, should be spilled into a separate dry well, or containerized and removed from the site. Inquire with the local health department as to their requirements.

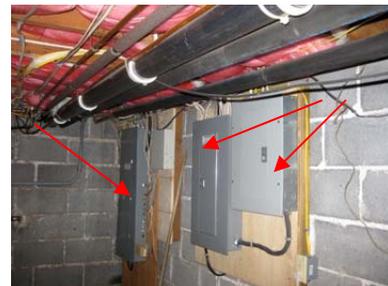
The 200-ampere, 120/240-volt electrical system enters the building via underground cables. The electric meter and main service disconnect switch are located on the exterior of the building. The main distribution panel is located in the rear left unfinished basement area. There are also sub panels

located in the same basement area (see photo). The main distribution panel has been fed with aluminum feeders. The sub panels have been fed with copper. Where visible the distribution conductors (wires) are copper, armored cable (AC/BX) and copper, non-metallic sheathed cable (NM/Romex) type conductors (wires). They were in generally acceptable condition. All circuit breakers in the electrical panel should be properly labeled for your safety and for your convenience. The electrical breaker switches in the panel should be tested on an annual basis. The four existing "Ground Fault Circuit Interrupter" (GFCI) safety breakers in the main panel should be tested monthly. The system appears to have been grounded to driven rods.

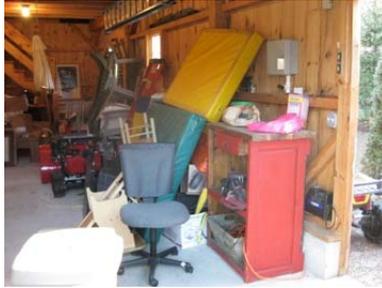
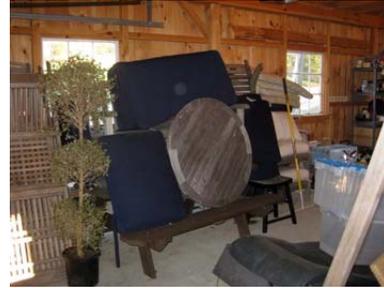
Due to the locations of the considerable amount of stored materials/belongings in the garage, we were unable to definitively verify its condition (see photos below).
