The pages to follow contain your TOTAL HOME INSPECTION report, which is based on observations made while conducting an inspection of ANY HOUSE, FAIRFIELD COUNTY.

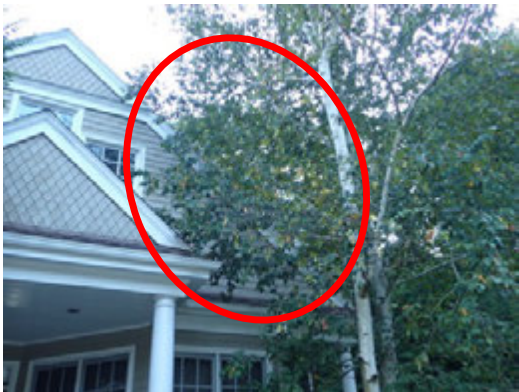
There are branches touching and overhanging the roof and gutter system (see photos left and right for example areas). By trimming or removing them, you will likely

reduce roofing, gutter and siding maintenance and repair and you will also remove a potential bridge for animals.

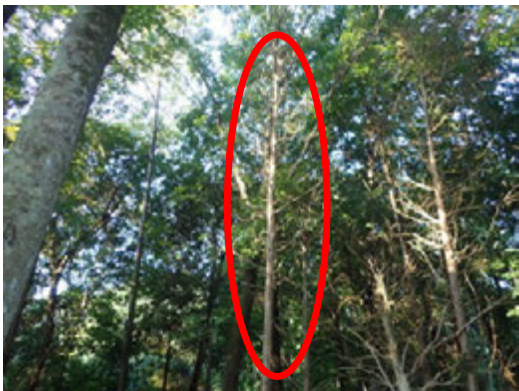
There are trees, which appear to be dead, at the rear left of the property (see photos left and right). We recommend that the trees be removed for your safety and to help prevent harm or

damage should the trees fall.

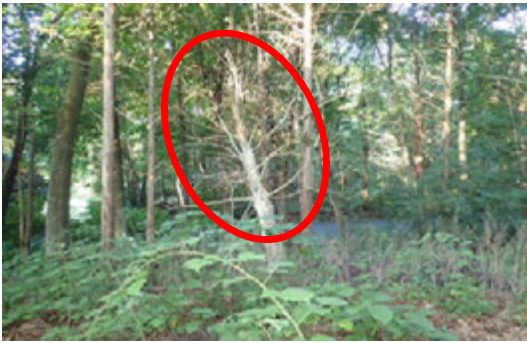
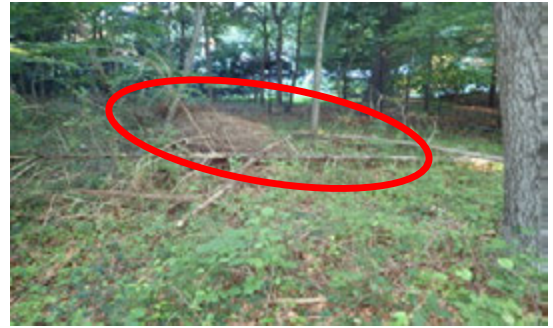
There are also fallen trees at the rear of the property (see photos left and right for examples). We recommend that the trees be removed for

your safety and to help prevent an environment conducive to attract insects.

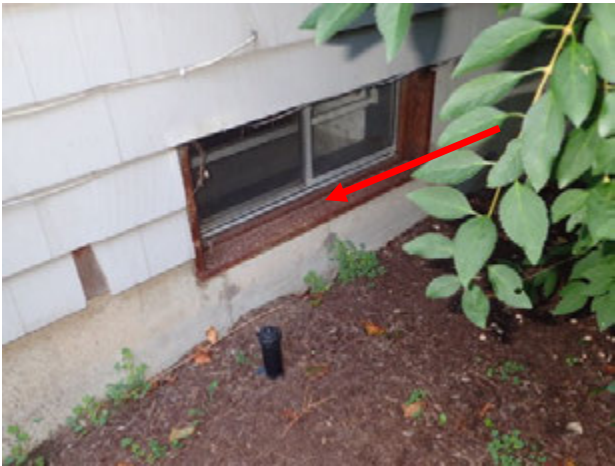
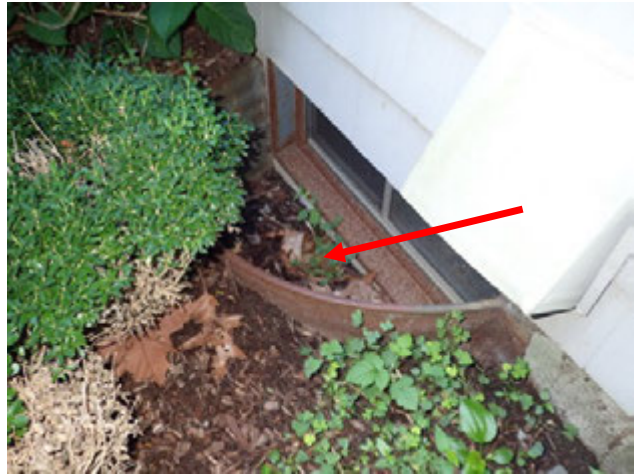
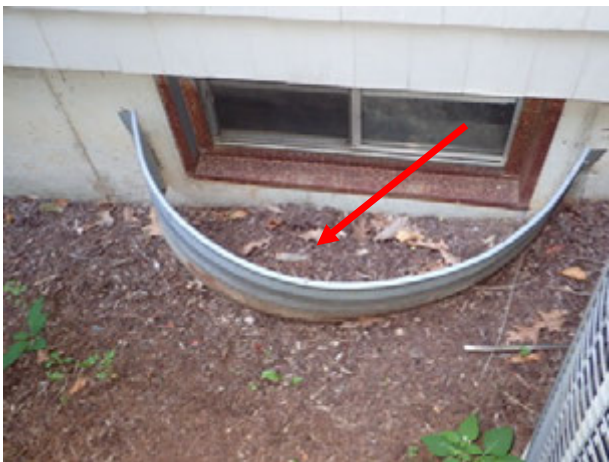
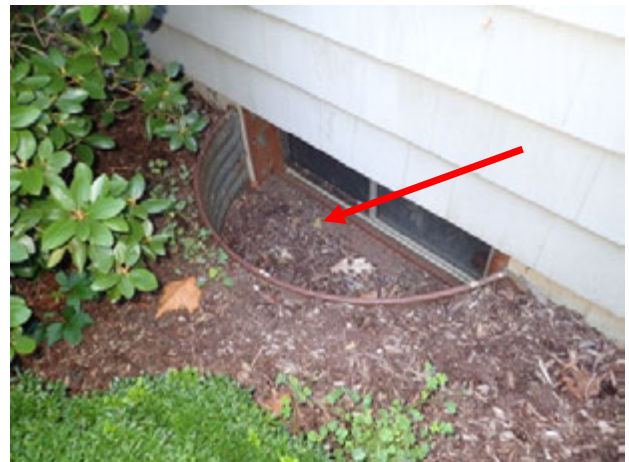
It may be necessary to install a window well around the front right side basement window (see photo below left) in order to build up the soil level as recommended above. Keeping the new well clean and keeping clean the existing windows wells at the left side of the house and the rear right side of the house (see photos below right and below left and right – 2nd row) will help avoid an inviting environment for insects or rot and help permit the at-grade or sub-grade levels to be properly ventilated when necessary. We recommend that the wells be protected with a clear plastic cover to prevent water accumulations in the wells, and to help minimize pressure on the foundation walls and possible seepage into the at-grade or sub-grade levels.

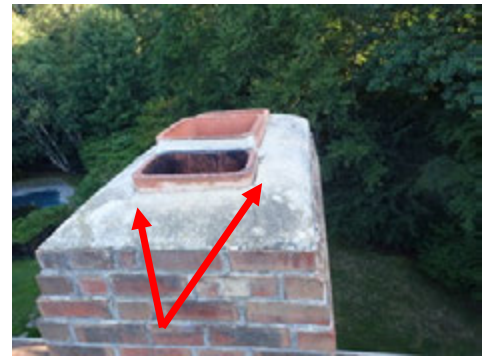
The cracks in the rear right chimney's crown (top of chimney – see photo right) should be sealed to prevent moisture from seeping behind the bricks and causing damage to the structure.

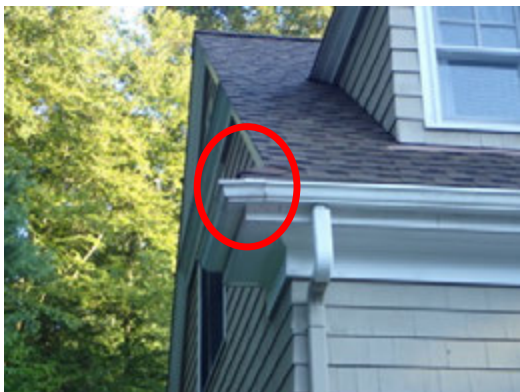
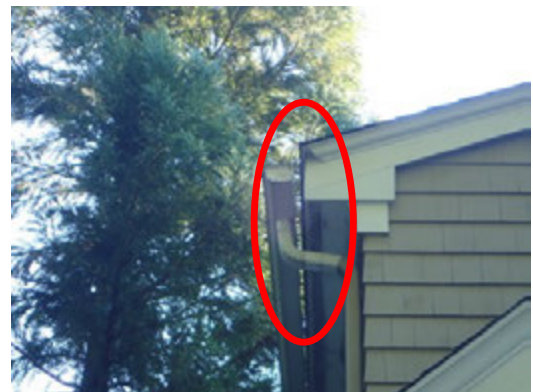
The gutters were in generally acceptable condition, but there is a sagging section of the guttering system at the front left corner of the house (see photo below left), a section of loosely installed gutter at the rear left of the house (see photo below right) and a disconnected leader at the front right side of the house (see photo below center (2nd row)). These sections of the guttering system's continued use in their present condition will likely cause damage to the fascia boards, soffits and surrounding wood members in that area. Due to the fact that it was not raining at the time of this inspection, it should be noted that it is virtually impossible for anyone to detect gutter leaks, except as they are occurring or by specific water tests, which are beyond the scope of the standard home inspection we have performed for you. Periodically check all joints for leaks and caulk where it is required. All gutters should be pitched toward their downspouts and the leaders should terminate as far from the building as practical. Gutters and rain leaders must remain free flowing at all times.

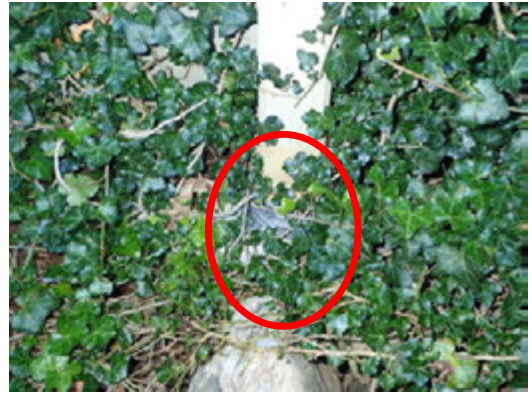
All rain leaders terminating into in-ground receptacles must remain free flowing at all times (see photo right for example of an in-ground receptacle). Underground systems are

vulnerable to clogging and should be checked annually. The rain leaders that do not terminate into an in-ground receptacle (see photo above left for example) need to be extended as far away from the foundation as practical to prevent roof water from collecting against the house and seeping into the lower level.

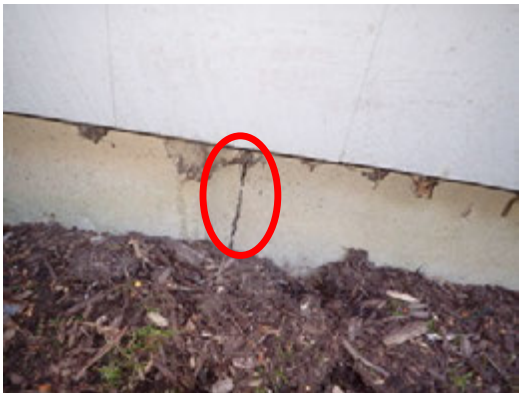
The foundation walls are poured concrete and concrete blocks. Settlement cracks were noted in the foundation at the time of the inspection (see photos left and right for examples).

Settlement cracks are not uncommon and are usually the result of improper soil grading around foundations. This condition is presently not a structural problem. It must be noted that settlement cracks could develop into structural cracks. Periodic inspection of these cracks and proper care should prevent future problems. These cracks should be filled from the exterior with a suitable material to help prevent seepage and they should be monitored for any further movement.

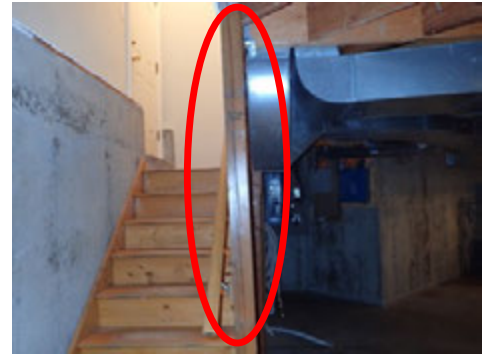
The framing for the stairs from the garage to the basement is supported by a 4" x 4" wooden post. The post was cracked ("checking"), a bit bowed and it was twisted (see photo right). We recommend that this post be replaced by a properly installed concrete filled, steel cased, Lally column.

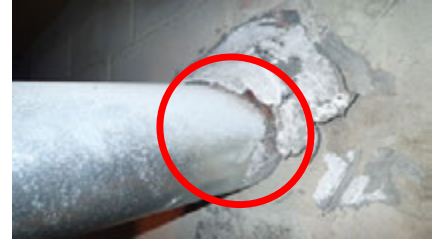
The draft control installed on the smoke pipe of the heating plant in the left side unfinished basement area requires repairs to function as designed. This device controls the draft at the combustion chamber. A proper operating draft control will result in fuel economy therefore a draft control should be installed.

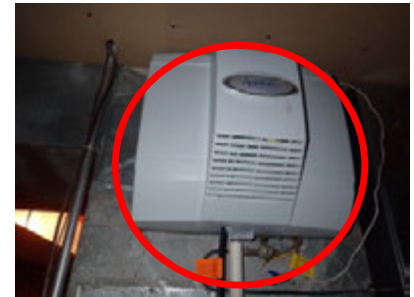
The humidifiers installed on both furnaces (see photos left and right) should be serviced in accordance with the manufacturer's recommended procedures. The humidifiers' bypasses should be open during the heating season and closed during the cooling season.

Humidifiers are prone to leaking (there was evidence of past leaking under these two humidifiers on the ductwork and on the furnaces' jackets that appeared to be from previously installed malfunctioning humidifiers). If leaking recurs, the humidifiers should be serviced promptly to prevent damage to the heat exchangers and/or to the ductwork. We do not recommend the use of this type of humidifiers.

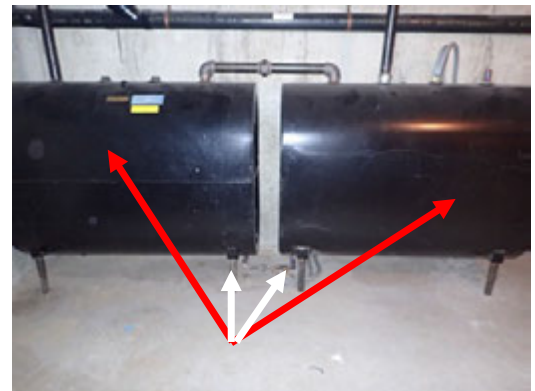
The visible areas of the two, 14-year old 275-gallon, oil storage tanks were in generally acceptable condition (see photo right - red arrows). Oil storage tanks have an average useful life expectancy of 30-40 years but the life expectancy can be affected significantly by the environment around the tanks.

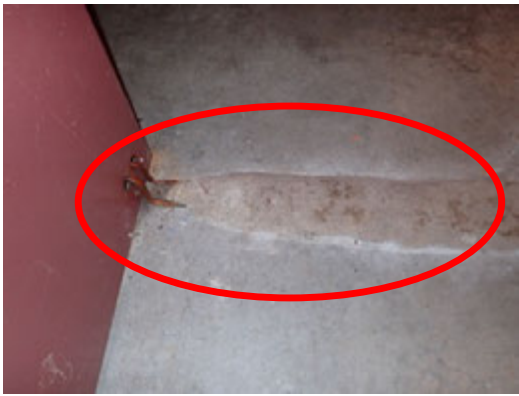
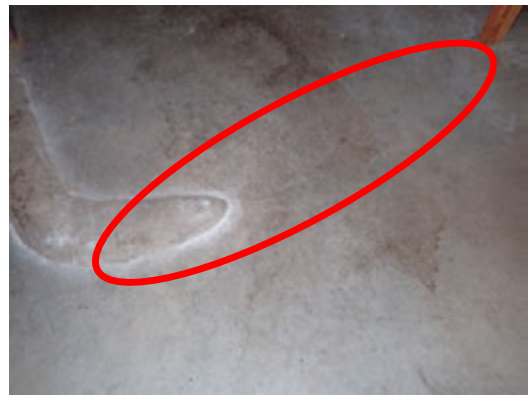
The oil supply pipes supplying the two furnaces (and the water heater) are covered with concrete and they run under the concrete slab floor (see photos left and right for example areas),

preventing evaluation of the oil supply pipes. If the oil lines are not protected with plastic sheathing, the copper pipes are likely to be adversely affected by their contact with the concrete. It should be noted that oil could leak from these pipes below the concrete. We recommend that you have your oil supplier re-route the oil lines as required to remedy this condition and that the pipes be encased in protective sleeves to help prevent damage to the pipes.

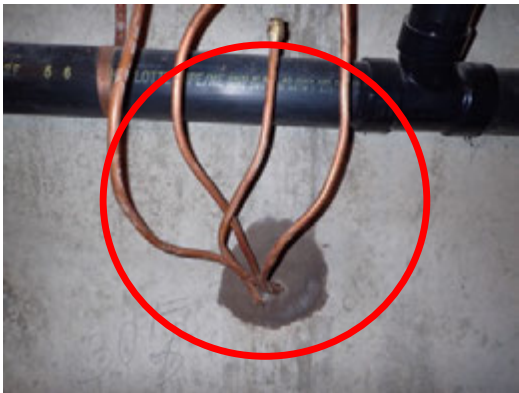
This house appears to have an abandoned or removed buried oil tank(s) (see photo left of clipped oil supply pipes penetrating the foundation wall). Abandoning or removing oil tanks should be done in accordance with all local, state and E. P. A. regulations. We recommend that you obtain the appropriate documentation confirming that the tank(s) has been abandoned or removed according to these regulations.

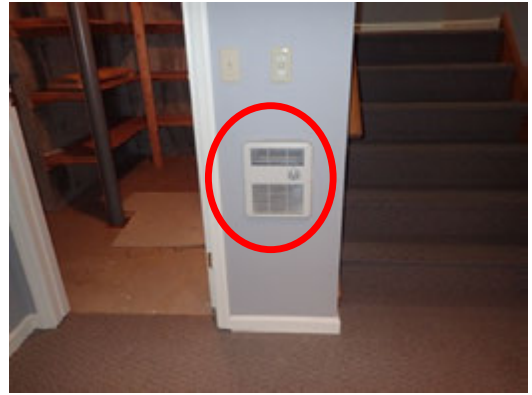
The finished basement is heated via one small independent electric resistant wall heater (see photo right). The heater was operated at the time of inspection and found to operate as designed. Be sure not to allow any electric cords, furnishings, draperies or flammable objects to rest against the electric wall heater while in use.

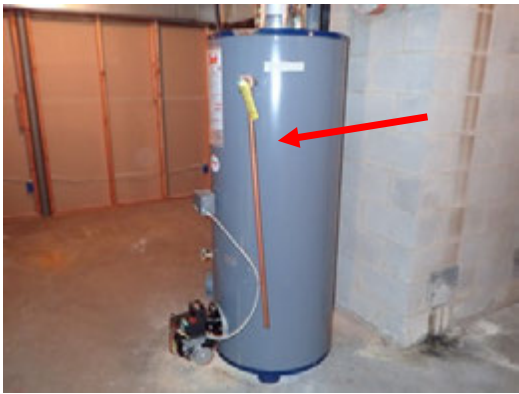
The water is heated by an independent, 70-gallon, oil-fired, Bock brand, water heater (serial # 03083180T/ model # 71E - see photo left) with a recovery rate of approximately 185 gallons per hour. The hot water supply system was evaluated and found to provide adequate amounts of hot water to all fixtures tested, at the time of this inspection.

Oil-fired water heaters require annual inspection and servicing. At that time, all safety devices should be serviced and adjusted to operate at peak performance. All flue passages should be cleaned. It is recommended that water heaters be flushed periodically to help prevent internal rusting and to maintain an efficiency level.

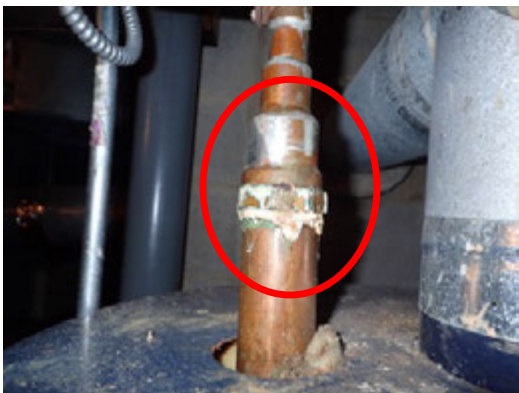
Corroded fittings were observed at the top of the water heater. When the water heater is serviced, make any necessary repairs to help prevent leaking and consequential damage.

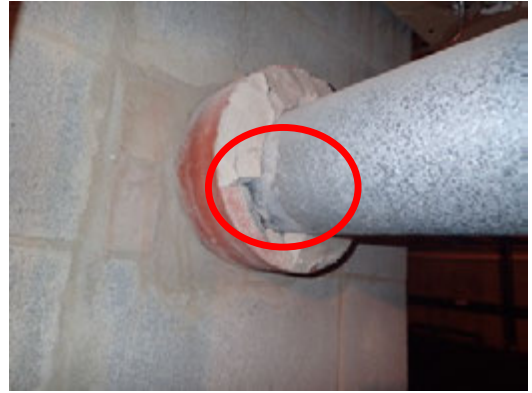
The smoke pipe-to-flue connection is not completely sealed (see photo right). We recommend that this area be sealed and secured to help ensure that no off-gases escape into the basement space and living area.

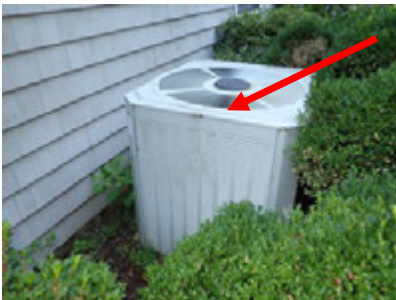
The Trane brand, electric, central air conditioning system's condenser/compressor (serial # R123XHL1F – see photo left) was activated using normal controls and it was found to be in acceptable working condition, at the time of this inspection.

The exterior compressor/condenser appears to be approximately 16 years old. Air conditioning systems that are properly maintained have an average useful life expectancy of 12-18 years.

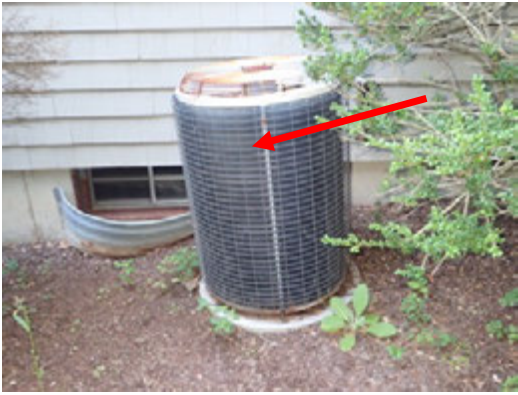
The Amana brand electric, air conditioning system (condenser/compressor serial # 9208228352 – see photo left) did not operate at peak performance levels at the time of the inspection. It is recommended that there is a 14-22-degree (Fahrenheit) temperature differential between the supply and return air of the system. There was a 8.9 degree (Fahrenheit) temperature differential measured during this inspection. This is probably due to lack of maintenance or to its apparent age (see comment below). Have the air conditioning system serviced, repaired or replaced and put into good working order. For maximum efficiency, service the equipment

The exterior compressor/condenser appears to be approximately 24 years old. Again, air conditioning systems that are properly maintained have an average useful life expectancy of 12-18 years. Your plans should include replacing the necessary components of the cooling systems when they fail.

annually. Keep the outside compressor area clear of shrubbery, debris or restrictions.

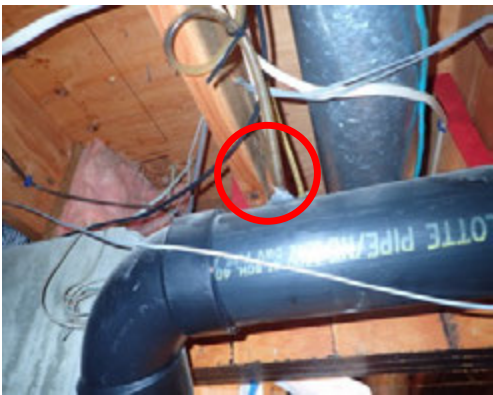
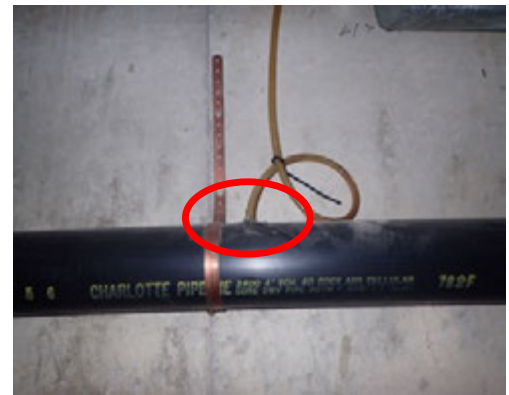
The condensation drains for the air handlers/evaporator units in the basement drain into the waste piping (see photos left and right). This is not recommended because when the “drain traps” dry out during the heating season, septic gases

can enter the air handler and possibly be distributed into the living spaces. We recommend re-routing the drains to the exterior of the house and sealing the waste pipes to prevent the gases from entering the basement space.

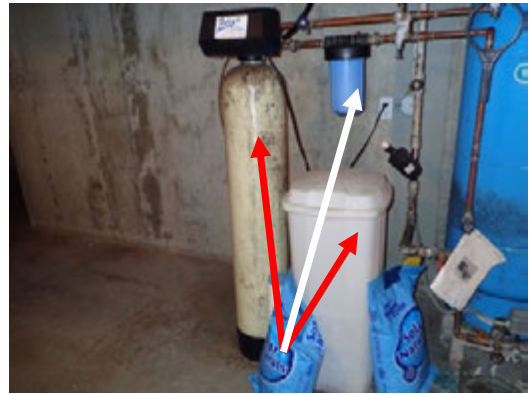
This house has water treatment equipment (see photo right – red arrows). The water treatment equipment was by-passed for one of the water analysis samples and included in a second sample. The results of this testing will also be forwarded to you directly by Aquatek Labs (203-389-1824) under separate cover, in approximately 5 business days. TOTAL HOME INSPECTION will not receive copies of the test results. Evaluating water treatment equipment is beyond the scope of a standard home inspection. There is no evaluation of the well water treatment equipment contained in this report.

Water treatment equipment requires maintenance. The maintenance depends on the type of equipment, intensity of use as well as the number and type(s) of contaminants in the feed water. The installing contractor or homeowner should instruct you on its operation, its maintenance and operation costs.

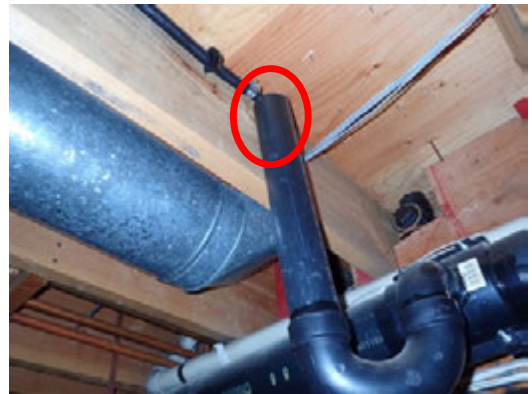
The backwash for the water treatment equipment empties into the septic system (see photo right). This is not recommended. Eventually the deposits in the backwash water may damage the system, clog the septic fields or filter down to the aquifers. The backwash, depending on its type, should be spilled into a separate dry well, or containerized and removed from the site. Inquire with the local health department as to their requirements.

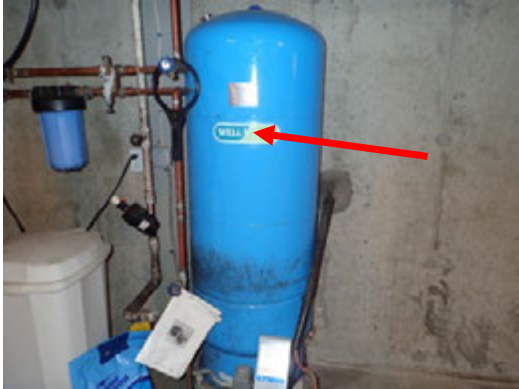
The Well-X-Trol brand bladder-type well water storage tank appears to be an older vessel (24 years old??), but the exterior of the tank was in generally acceptable condition (see photo left). This type of equipment deteriorates from the inside out depending upon what effects the water has on the interior materials. Because the interior is not visible, its condition cannot be determined. Monitor the tank for leaking or malfunctions. You should consider replacing the tank sooner, rather than later to help ensure good water pressure.

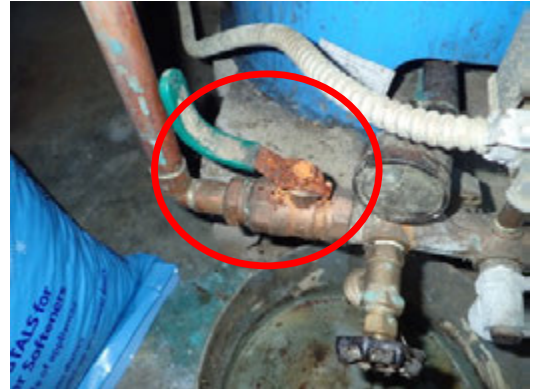
The main water supply piping from the well is plastic. The main shut-off valve is located in the basement, near the base of the aforementioned well water storage tank (see photo right). The main water shut-off valve was corroded. We recommend that the valve be replaced to help ensure that it functions as designed when needed and to help prevent leaking and consequential damage.

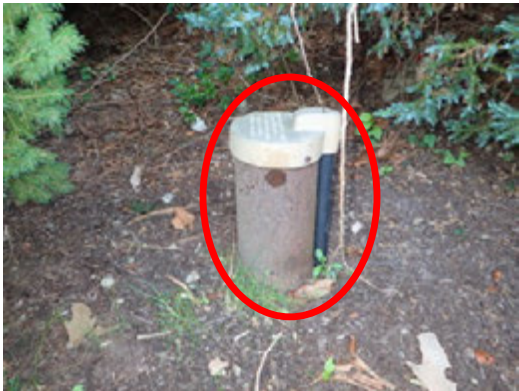
The well pump is submersible (see photo left of well casing and well cap in the left side planting area) and it was not accessible for visual inspection. After running the water for a measured period of time, there were no indications of any well pump malfunctions.

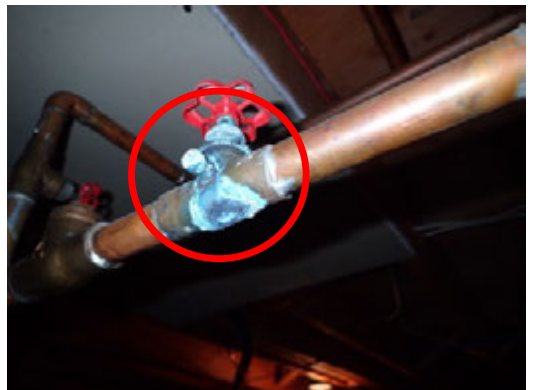
The corroded fitting observed in the rear right unfinished basement area (see photo right) should be monitored for any further deterioration and it should be repaired when necessary to help prevent leaking and consequential damage.

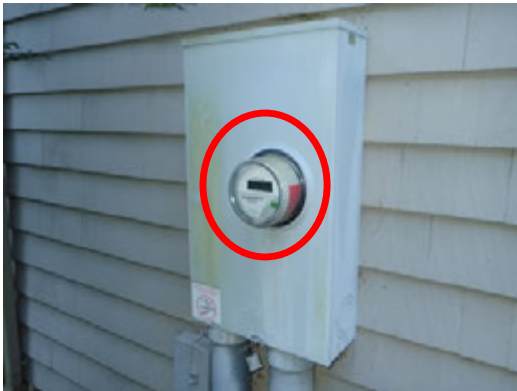
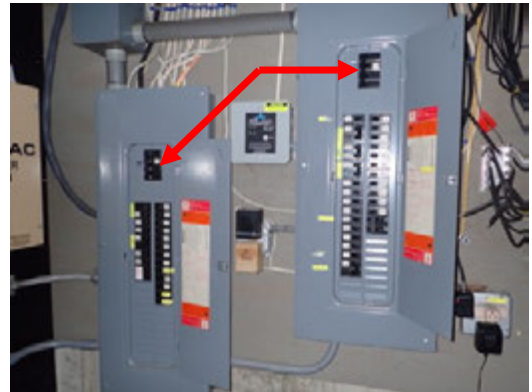
The 400-ampere (2 x 200 amperes), 120/240-volt electrical system enters the building via underground cables. The electric meter is located on the exterior of the

building (see photo left). The main service disconnect switches and primary panel boards (load centers) are located in the basement (see photo above right). There are also secondary panel boards (sub panels) located in the basement near the main electrical panel (“generator panel”) and in the storage closet at the base of the stairs from the first floor (see photos below left and right respectively). The panels have been fed with aluminum feeders. Where visible the distribution conductors (wires) are copper, non-metallic sheathed cable (NM/Romex) type conductors (wires). They were in generally acceptable condition. All circuit breakers in the electrical panel should be properly labeled for your safety and for your convenience. The electrical breaker switches in the panel should be tested on an annual basis. The system appears to have been grounded to a driven rod.

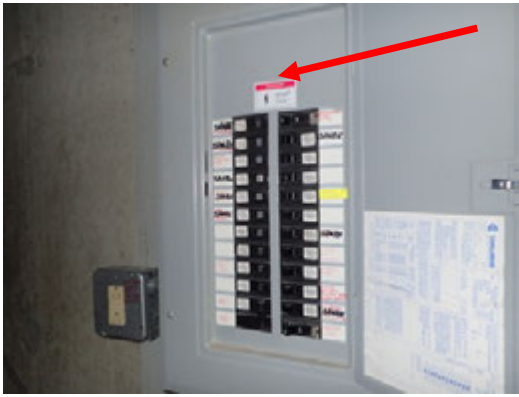
This house has been fitted with a generator system in case of a power outage (see photo left). Evaluating generator systems is beyond the scope of the standard home inspection we performed for you, therefore no evaluation of the system is included in this report. Inquire with the seller or a qualified contractor that specializes in generators regarding the proper operation of this system. We also recommend that you inquire with the seller as to whether the generator is included in the purchase price of the house.

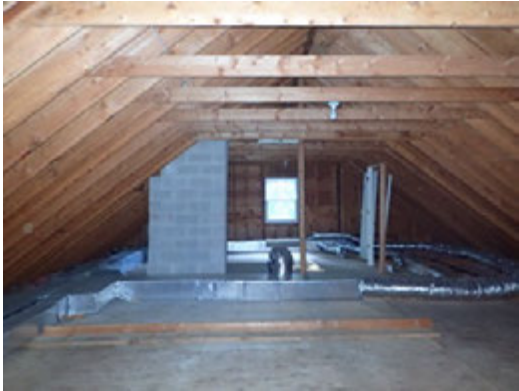
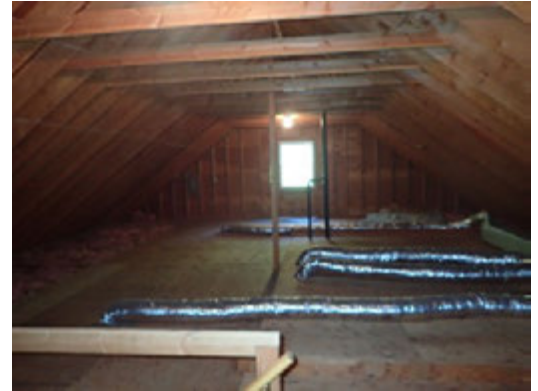
The attic was accessed by a walk-up staircase from the 2nd floor hallway and it was inspected from within (see photos left and right for views of the attic at the time of this

inspection).

The accessibility, structure, ventilation, insulation, lighting and flooring were in generally acceptable condition. Consider the addition of more floored areas in the attic space to make the area even more suitable for storing your belongings.

Modifying the guard railing at the staircase opening by adding balusters or screening will help prevent children from falling through the railing and contribute to general safety.

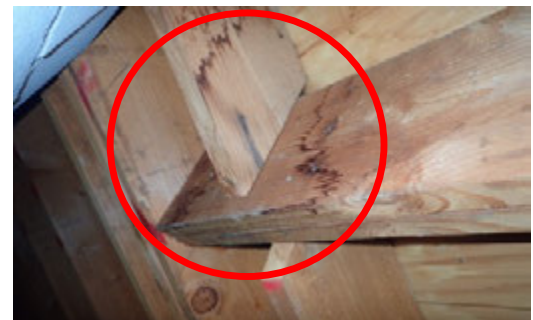
There was evidence of past water infiltration in the attic space near the chimney (see photo right). The water stains were dry at the time of this inspection. Inquiring with the seller may give you insight as to the time, nature and cause of the staining, as well as any corrective measures that were under taken.

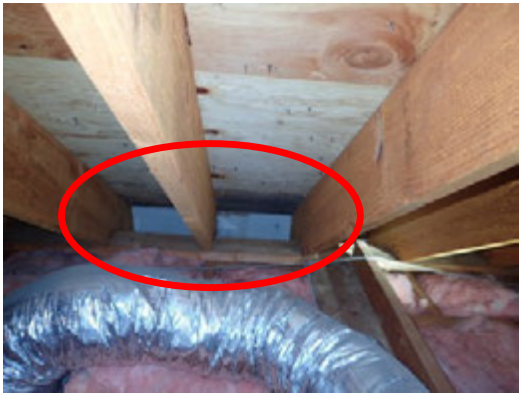
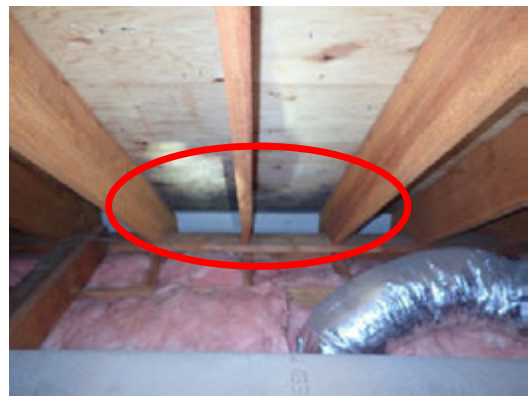
Black, microbial growth-type staining was observed in the attic (see photos left and right for example areas). Again, determining the presence or absence of mold, pathogenic

and/or toxic substances inside or outside the dwelling is beyond the scope of the standard home inspection we have conducted for you. The determination to have a mold test or evaluation performed or to correct an identified mold condition is entirely yours, and should be done based upon the full scope of information available to you through your own due diligence.

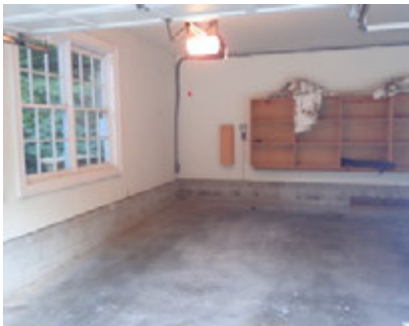
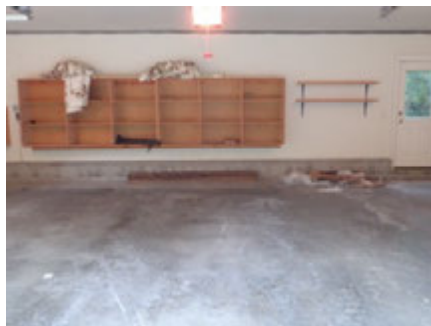
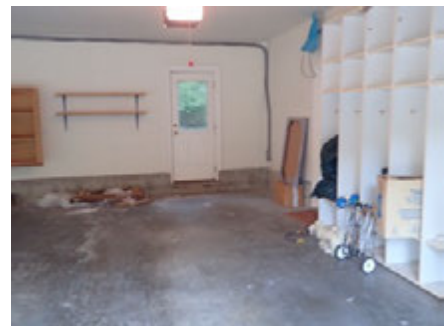
The "heated" three-car garage has a concrete floor. The walls are concrete blocks, concrete and gypsum board. The ceiling is gypsum board (see three photos below left, below center and below right for views of the garage bays at the time of this inspection). All were found to be in generally acceptable condition, with the observations to follow to be taken into account and corrections made as required.

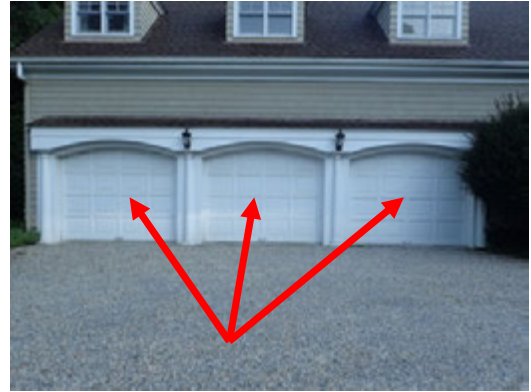
The garage has been fitted with three electrically operated, overhead doors (see photo right). The doors were spot tested and found to be in proper working condition, with their safety reversing functions operating adequately to help prevent entrapment. The doors' reversing actions should be tested frequently and kept in good working order for your safety.

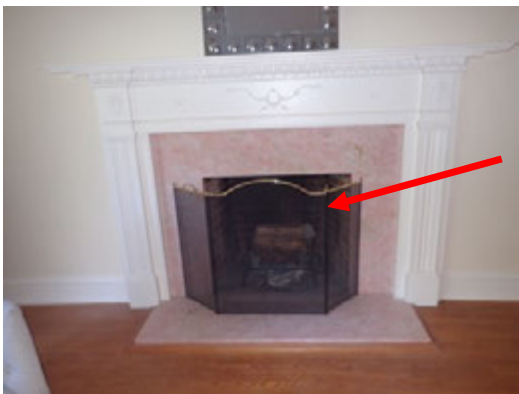
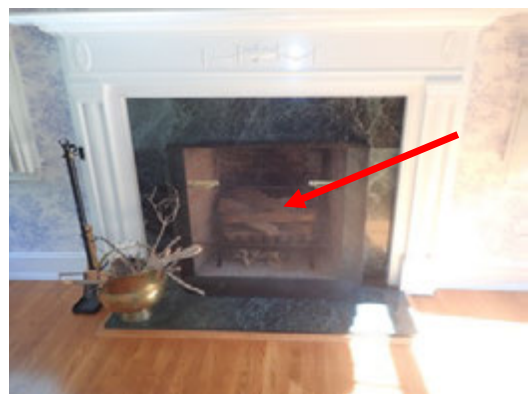
The masonry fireplaces in the master bedroom and the rear center bedroom (see photos left and right) as well as their components were in generally acceptable condition.

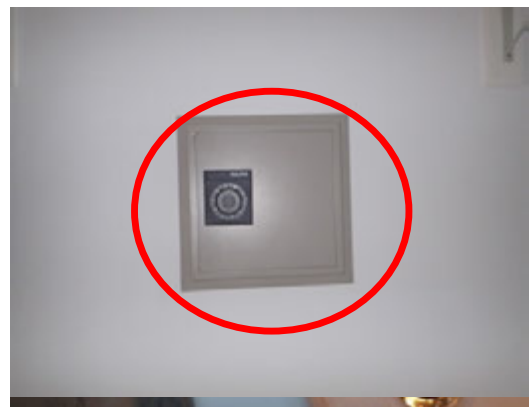
We recommend that you obtain the combination to the safe in the closet (see photo right) for your convenience.

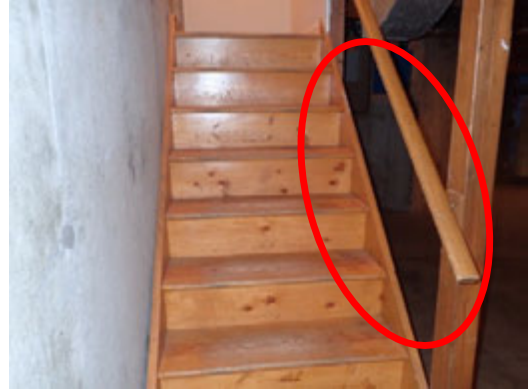
- Staircase: Modifying the hand railing at the garage to basement steps (see photo right) by adding balusters or screening will help prevent children from falling through the railing and to contribute to general safety.
- Exercise Room: Replace the cracked mirror for your safety.
